Structural Audit of a Heritage Structure: A Case Study

Abstract

A visit was planned on 4 March, 2017 to have a reconnaissance survey for the investigation of the rock from Alandi Temple - Shree Dnyaneshwar Maharaj Samadhi Mandir. Alandi (18°40'37.42"N 73°53'47.76"E) is located on the holy banks of the Indrayani River, 20 km north of Pune. The studies of the petrographic rocks was carried out for some specimens of the temple and are assumed to be the representative of the whole temple. The samples collected were from the nearby vicinity of the temple and within the temple region like the Mahadwar, second door entrance of temple, some newly constructed region within temple, outside the temple and the temple from ghat region.

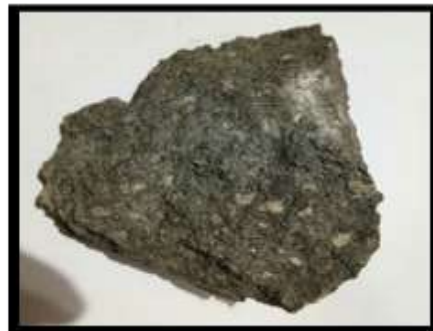
Hand Specimen: Fine-grained, greenish black rock comprising dark and white minerals. Contains amygdales, mostly white, though some have black cores. Fine-grained plagioclase laths and irregular clinopyroxene (augite) grains, replaced with calcite. Many of the plagioclase laths have been almost entirely altered. The amygdales are filled with zeolite, growing in spherulitic and radiate patterns. Many have rims of calcite and fine-grained chlorite. Some vein material - granular quartz with sutured contacts

Fig. (1) Hand specimen of Cuprite Amygdal outside the temple area.

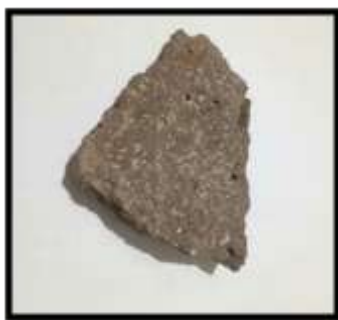
Hand Specimen: Fine-grained, reddish grey rock comprising dark and white minerals. Contains calcic material as cementing in it with glassy nature of minerals. Some discrete plagioclase crystals exhibit irregular oscillatory zoning. Glass inclusions are found in the clino-pyroxene and plagioclase crystals

Fig. (3) Hand specimen of RTB

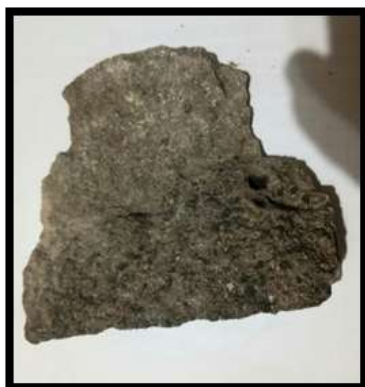
Hand Specimen: Fine to medium grained, greenish black rock comprising dark and white minerals. Contains amygdales, vesicles and founds to be weathered magnetite mineralization in the specimen. During the preparation of the thin section the sample was loosely holded so was unable to prepare the thin section and hence no data could be acquired during the microscopic studies of this specimen

Fig. (5) Hand specimen of Mahadwar

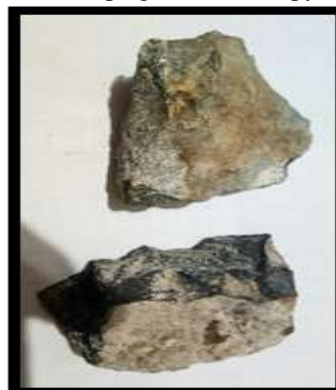
Fig. (6) Hand specimen of RTB

Hand Specimen: Fine-grained, grey rock comprising dark minerals covered by white cementing material showing pale yellow colour of it. Contains calcic material as cementing in it with glassy nature of minerals. Main Temple Diabase (magnification 40X) is an Intrusive Igneous Rock, which means a magma formed deep in the Earth was emplaced in the crust and cooled slowly. Evidence for slow cooling can be seen in the crossed polars picture, in which Plagioclase grains (white grains with dark striping due to Crystal Twinning) are

partly to completely enclosed by Pyroxene grains (all the colored grains: yellow, orange, red, and blue). This is called an ophitic texture, and indicates that the minerals crystallized out of the magma to in a certain order: first plagioclase, then pyroxene.

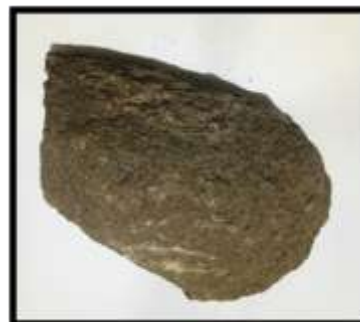
Hand Specimen: Fine-grained, brownish black rock comprising dark and white minerals. Contains amygdales, mostly white, though some have black cores. Thin-section of Basalt weather II door foundation. The black grains visible in the 50x plain light image of Basalt are opaque oxide grains, probably Magnetite. Other parts of the thin section, which are clear in plain light but black with the polarizers crossed, are natural volcanic glass (what's left of the lava, now frozen solid like windowpane glass).

Fig. (8): Hand specimen of Basalt weather II door foundation.
