Failure Analysis of Crankshaft by Finite Element Method-A Review

Ms.Shweta Ambadas Naik

Abstract— The crankshaft is an important and large component of an engine. The function of crankshaft is to convert the reciprocating displacement of the piston into a rotary motion. In this paper, the stress analysis and modal analysis of a 4-cylinder crankshaft are discussed using finite element method. The 3D model of crankshaft was developed in PRO/E and imported to ANSYS for strength analysis. In this study, failure analysis of a crankshaft was carried out. Several causes are there to failed the crankshaft. All crankshafts were failed from the same region. Failures had occurred in the first crankpin, the nearest crankpin to the flywheel. Dynamic analysis and finite element modelling were carried out to determine the state of stress in the crankshaft. Finite element analysis was performed to obtain the variation of stress magnitude at critical locations. We know that, the performance of any automobile largely depends on its size and working in dynamic conditions. The design of the crankshaft considers the dynamic loading and the optimization can lead to a shaft diameter that satisfying the

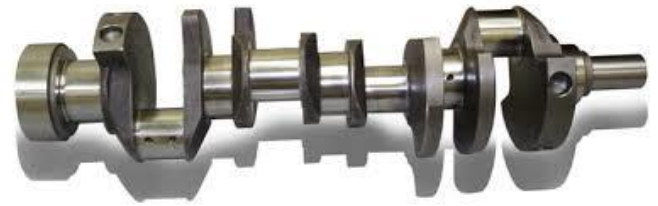
Fig-1 :crankshaft

The crankshaft is as shown in fig-1 used for conversion between reciprocating motion and motion. In order to do the conversion between two motions, the crankshaft has "crank throws" or "crankpins", additional bearing surfaces whose axis is offset from that of the crank, to which the "big ends" of the connecting rods from each cylinder attach. A crankshaft is as shown in fig-2 consist of main journals, connecting rod journals (crank-pins), counter weight, oil hole and a trust bearing journal. During the service life, combustion and inertia forces acting on crankshaft structure, which generally causes the two types of loading-torsional load and bending load. It is connected to a flywheel to reduce the pulsation characteristic of the four-stroke cycle, and sometimes a torsional or vibrational damper at the opposite end, to reduce the torsional vibrations often caused along the length of the crankshaft.

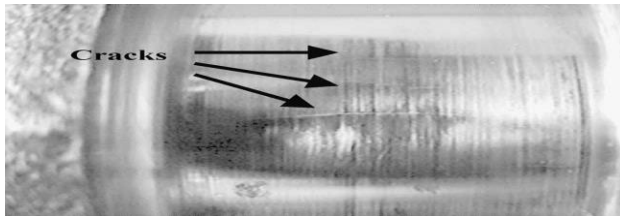
Fig. 3. Finer detail of journal 4 of crankshaft 2.

enough to damage the journals. The contact between the bearings and the journals would essentially promote a rougher surface of the journals. The heat and stresses during the contact would also eventually promote the propagation of existing cracks, A finer detail of the cracks is shown in fig.3

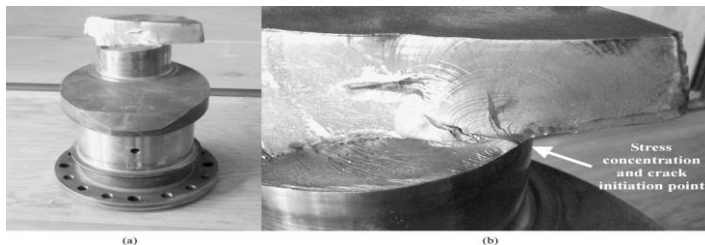
Fig. 4. Train crankshaft failure: (a) part of the crankshaft; (b) mechanical fatigue crack developed at a stress concentration.

Misalignments of the crankshaft on assembly, improperly straightened cranks due to improper repairing, or worn bearings would create a bending moment and higher stresses at the crankshaft. This would also be the effect of vibrations. These higher stresses would originate mechanical fatigue cracks at the weakest points of the crank and the crank would fail by fracture. Fig. 4 shows an example of a train crankshaft that failed due to mechanical fatigue. As can be seen the crack developed at the radius at the geometrical discontinuity.

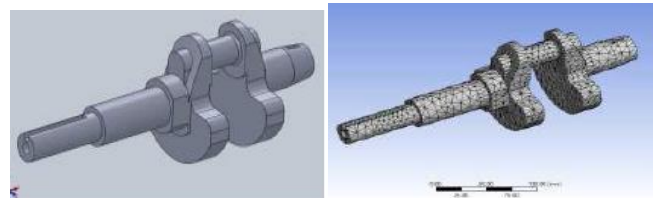
Fig-5 :-Crank Shaft in Ansys

Jaimin Brahmhatt1, Prof. Abhishek choubey[2] carried out the design and analysis of crankshaft for single cylinder 4-stroke diesel engine. In this paper a dynamic simulation is conducted on a crankshaft from a single cylinder 4- stroke diesel engine. This analysis is done for finding critical location in crankshaft, stress variation over the engine cycle and the effect of torsion and bending load. Von-mises stress is calculated using theoretically and FEA software ANSYS. The relationship between the frequency and the vibration modal is explained by the modal and harmonic analysis of crankshaft using FEA software ANSYS. Fig-5 shows the crankshaft model in ANSYS and Fig-6 shows meshed model of crankshaft. Tetrahedrons element is used for meshing.

Fig 6:- Meshed model

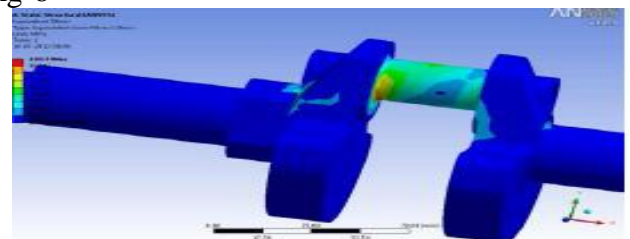
Fig 7: Von mises stress

Define boundary condition for analysis, after applying the Load, Run the analysis. Von mises stresses are calculated and as shown in fig7. Applying the maximum force at phase angle 355°, corresponding Deformation is measured as shown in Fig-8

Above Results Shows that FEA Results matches with the theoretical calculation. From fig-8, we can say that the maximum deformation appears at the center of crankpin neck surface. The maximum stress appears at the fillets between the crankshaft journal and crank cheeks and near the central point Journal. The edge of main journal is high stress area. The Value of Von-Misses Stresses that comes out from the analysis is less than material yield stress, so our design is safe and we should go for optimization to reduce the material and cost.

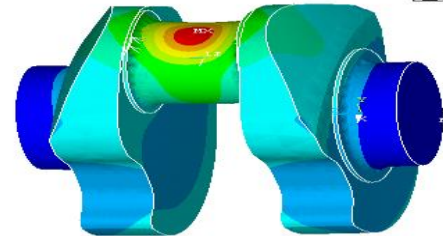
Fig-11: Deformation distribution

Jian Meng, Yongqi Liu, Ruixiang Liu(2011)[3] carried out the work on Finite Element Analysis of 4-Cylinder Diesel Crankshaft. In this paper, The stress analysis and modal analysis of a 4-cylinder crankshaft are discussed using finite element method. Pro/ENGINEER software is used to create 3D model of 480 diesel engine crankshaft and crankthrow as shown in fig-9. The relationship between the frequency and the vibration modal is explained by the modal analysis of crankshaft. The results would provide a valuable theoretical foundation for the optimization and improvement of engine design. The crankpin model was meshed by solid45 which has 8 nodes tetrahedral feature. Fig 9 shows the meshed model by solid 45. After defining the boundary conditions, the simulation can be started. As the number of elements is large, Pre-Condition CG solver was used here. The results of simulation is given in fig. 11. The maximum deformation is 0.0685mm at the most critical loading condition. The maximum deformation appears at the center of crankpin neck surface.

The maximum deformation appears at the center of crankpin neck surface. The maximum stress appears at the fillets between the crankshaft journal and crank cheeks, and near the central point journal. The edge of main journal is high stress area. The crankshaft deformation was mainly bending deformation under the lower frequency. And the maximum deformation was located at the link between main bearing journal and crankpin and crank cheeks. So this area appear the bending fatigue crack. Base on the results, we can consider the possibility of mutual interference

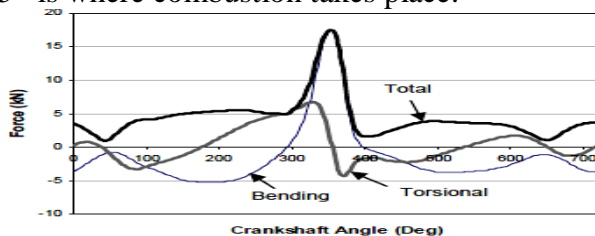
Fig 14: Bending, torsional, and the resultant force at the connecting rod bearing at the engine speed of 3600 rpm.

Farzin H. Montazersadgh and Ali Fatemi (2007) [4] conducted a study on Dynamic Load and Stress Analysis of a Crankshaft. In this study a dynamic simulation was conducted on a crankshaft from a single cylinder four stroke engine. Finite element analysis was performed to obtain the variation of stress magnitude at critical locations. The dynamic analysis was done analytically and was verified by simulation in ADAMS. The analysis was done for different engine speeds and as a result critical engine speed and critical region on the crankshaft were obtained. Stress variation over the engine cycle and the effect of torsional load in the analysis were investigated. FE analysis was verified by strain gages attached to several locations on the crankshaft. Results achieved from this analysis can be used in fatigue life calculation and optimization of this component. We know that, due to forces applied to the crankshaft cause bending and torsion. Fig 14 shows the variations of bending and torsion loads and the magnitude of the total force applied to the crankshaft. The maximum load which happens at 355° is where combustion takes place.

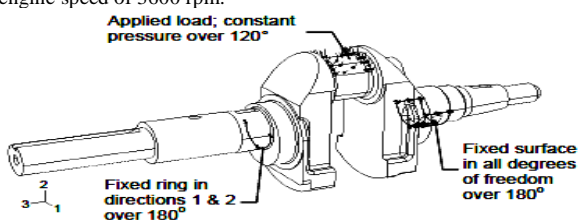
Fig-15: Boundary condition used in a FEA Model

The boundary conditions are shown in Fig 15. Boundary conditions rotate with the direction of the load applied. Some locations on the geometry were considered for depicting the stress history.

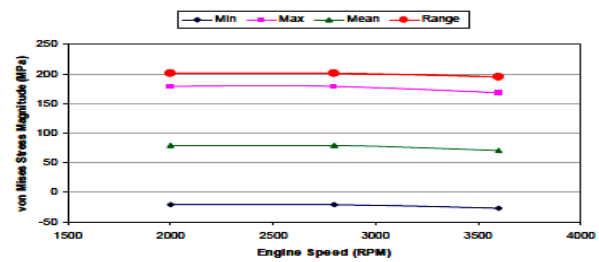
Fig 16: Variation of minimum stress, maximum stress, mean stress, and stress range at location 2 on the crankshaft as a function of engine speed

Fig 16 shows the effect of engine speed on minimum, maximum, mean and range of stress. This figure indicates the higher the engine speed, the lower the von Mises stress. When the engine speed increases are wear and lubrication. The conclusions from this study is Dynamic loading analysis of the crankshaft results in more realistic stresses whereas static analysis provides an over estimate results. Accurate stresses are critical input to fatigue analysis and optimization of the crankshaft. There are two different load sources in an engine; inertia and combustion. These two load source cause both bending and torsional load on the crankshaft. The maximum load occurs at the crank angle of 355 degrees for this specific engine. At this angle only bending load is applied to the crankshaft. Considering torsional load in the overall dynamic loading conditions has no effect on von mises stress at the critically stressed location. The effect of torsion on the stress range is also relatively small. Therefore, the crankshaft analysis could be simplified to applying only bending load.

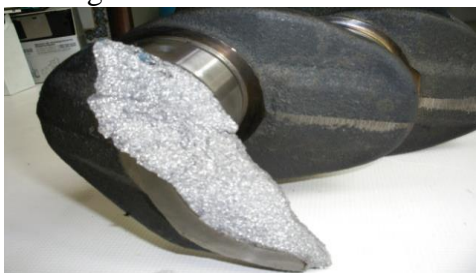
Fig-17: The fractured surface of the crankshaft

SEM images of the fractured surface also showed cleavage fracture and put in evidence that the failure was brittle fracture. No sign of fatigue failure was observed. The fracture may have been caused by an overload. However, the results suggest re-evaluation of the design and manufacturing. The fillet rolling may play an important role in this study. Optimization of the fillet rolling process by changing process parameters has been recommended to the manufacturer. This recommendation has been adopted by the manufacturer and no further fracture has been reported. The crankshaft was made from GGG 70 ductile cast iron. A broken crankshaft is shown in Fig. 17. The Fractured surface shows a brittle appearance and no Beachmark was observed on the failed region.

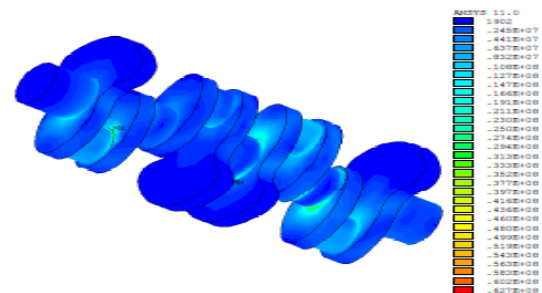
Fig:18 -Equivalent von Mises stress distribution

N.m torque was applied to the extreme surfaces of the crankshaft. Four cases, i.e. combustion in each cylinder, were examined by alteration of the boundary condition in the finite element model. Results found that the most dangerous case has occurred in the first crankpin when the third cylinder was combusted. The equivalent von Mises stress distribution of the whole crankshaft during combustion of third cylinder is shown in Fig. 18. The maximum equivalent stress is 62.7 MPa which is about 15% of the yield stress of the material.

The conclusion for this study includes, FEM results revealed that the first crankpin fillet is the most vulnerable point to fracture. SEM images of the fractured surface also showed cleavage fracture and put in evidence that the failure was brittle fracture. Based upon results, author suggest re-evaluation of the design and manufacturing. By changing process parameters, optimization of the fillet rolling process has been recommended to the manufacturer. This recommendation has been adopted by the manufacturer and no further fracture has been reported

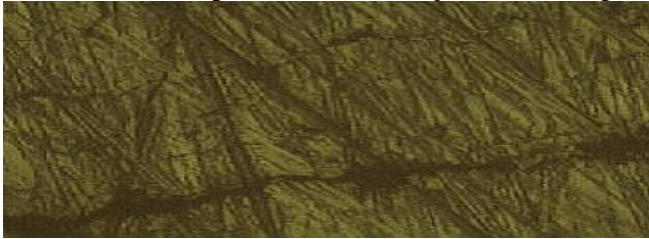
Figure 19. View of the main crack and a micro-crack

In this study, a failed crankshaft reported by automotive service technicians was examined to determine causes of the failure. After the cleaning and visual examination, journals of the crankshaft were cut for failure analysis. The chemical composition of the failed crankshaft material was determined with spectroscopy chemical analysis method with Thermo ARL 3460 test machine. From the visual examination, a crack was determined on the surface of 4th pin journal. The main crack propagated axially along the surface of the journal from one side to other. There were scratches on surface of the 4th pin and 5th main journals in fig 19 .

Examination showed that the main crack and micro-cracks were superficial on surface of the journal. A good nodularity of graphite was observed in microstructure of the crankshaft material as shown in fig- 20.

The main reason of the failure was thermal fatigue because of contact of journal and bearing surface. The contact can be resulted from two reasons which are lubricating problems, assembling problems. For the failure analysis, assembling problems can be eliminated because, before the crack problems, the automobile has been driven for long time (58 000 km). In addition, from the lubricating problems, oil absence was eliminated, because automotive service technicians reported that level of the engine oil was suitable during the first examination. Some results were concluded from failure analysis of the crankshaft: Visual examination with microscopy showed that the main crack and micro-cracks propagated axially along surface of the 4th pin journal. In addition, there were scratches on surface of the 4th pin journal and 5th main journal.
