Original Article

# Strength Characterization of Historical Masonry Building in Kathmandu Valley, Nepal

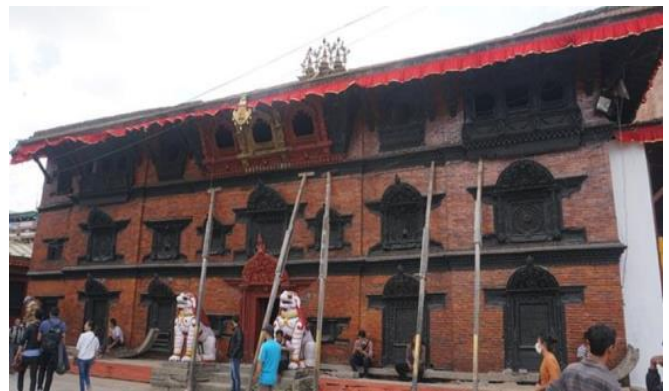
Fig. 1 Kumari chhe

The building exists at 27°42'13.752"N, 85°18'24.0156" E Kumari Chhe (Kumari Residence) is a brick masonry building in mud mortar built in traditional Newar architecture and technology in 1757 by King Jaya Prakash Malla shown in Figure 1. The building was built as a residential building for the living goddess Kumari, who is believed to be the reincarnation of Goddess Talaju. Kumari Ghar was improvised and renovated in 1966 AD.

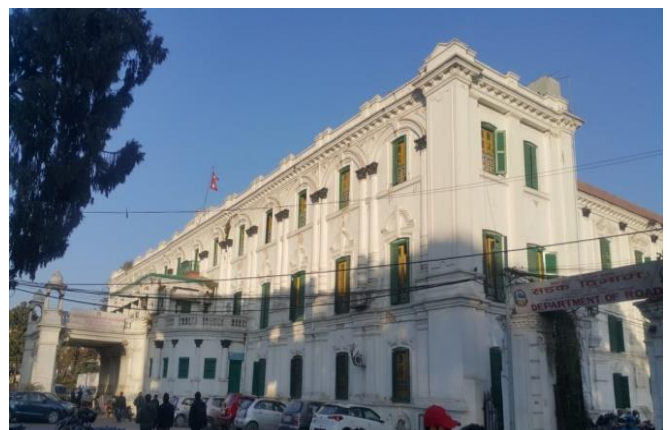
Fig. 5 Babar mahal

The Baharmahal Palace complex is in an inalienable Neoclassical style built in brick masonry with mud mortar and five courtyards, as shown in Figure 5. After the fall of the Rana regime, Baber Shamsher Jang Bahadur Rana occupied and controlled Babar Mahal and later sold it to the Government of Nepal

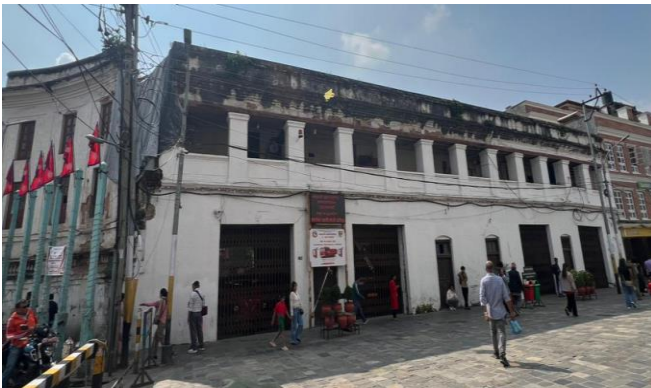
Fig. 7 Juddha fire brigade

The building is located at 27°42'55.93"N, 85°18'50.78"E, Nepal's first fire brigade. In the name of Juddha Shumsher Jang Bahadur Rana, a mud mortar brick masonry building was constructed in 1937 AD, reflecting Rana Architectusnip, shown in Figure 7. Before the Gorkha Earthquake 2015, a 39.01 m x 9.8 m dimension building was used as a fire brigade building.

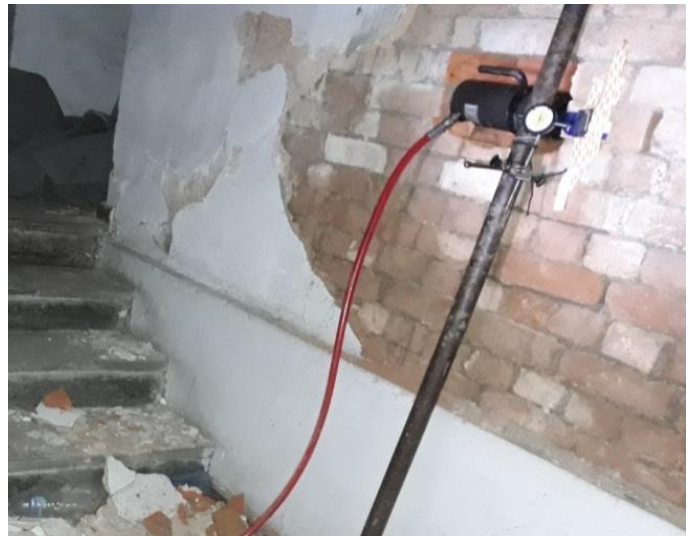
Fig. 8 In-situ shear test

In-situ shear strength of clay masonry units and their mortar joints is evaluated using a non-destructive testing method. As shown in Figure 8, a hydraulic jack is placed in the position of the removed masonry unit. The mortar on the subsequent brick at the side is removed to isolate the test unit, allowing for horizontal displacement upon applying force.

The test unit slides when applying force parallel to the wall's length. Force measured at the masonry unit's initial movement is then divided by its total contact area to determine the shear strength. The non-destructive test assesses the in-situ shear strength between a clay masonry unit and the mortar joints above and below it.

As with the Compressive Strength Test, the number of tests depends on the site. A horizontal void in the wall is made to install the hydraulic jack horizontally to evaluate the shear in masonry. The orientation of the hydraulic jack is kept parallel to the brick alignment, and pressure is applied. The mortar of the adjacent brick is removed, allowing horizontal displacement. The applied pressure and horizontal displacement were recorded to determine compression and shear tests. Mortar of adjacent brick Test results for an individual building are also shown in Table 4.

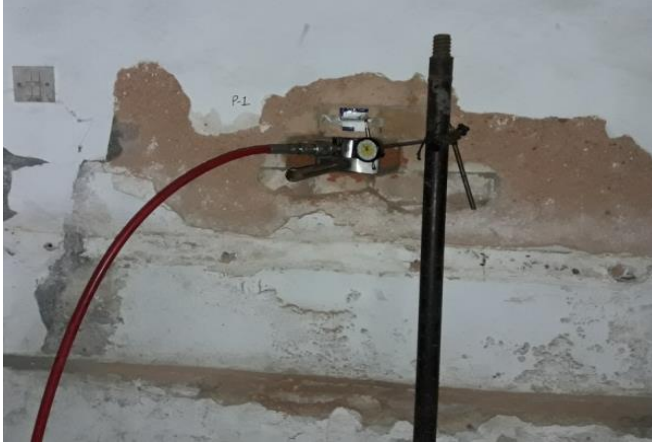
Fig. 9 In-situ Compression test

The non-destructive test for masonry walls measures the in-situ compressive strength. Two points in the wall are identified to determine the vertical deflection. A hydraulic jack is positioned vertically in a space created by the extraction of a masonry unit. The hydraulic jack is pressurized to the deflected wall until its original position is reached, estimated by the two points marked before the removal of the masonry unit, as shown in Figure 9. The stress evaluated to regain the original position of the deformed masonry wall is estimated as developed compressive strength at the time of test observed on the test panel of the building.

An in-situ test was performed to acquire the mechanical parameters of selected brick masonry buildings. Shear test and compressive test were conducted at different locations of the building. Using the FEMA 274 (FEMA 274, 1997) guidelines. The numbers of test locations and sample collections are different due to restrictions for sample collection and accessibility. A vertical void in the wall is made to install the hydraulic jack to evaluate the compression strength. The orientation of the hydraulic jack is kept perpendicular separately to determine compression tests. Tested results for an individual building are also shown in Table 2. At least three minimum number of tests were performed in each building.

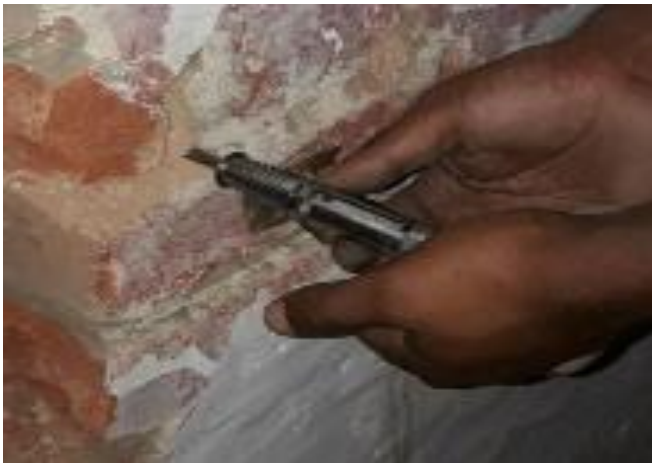
Fig. 10 Pocket penetrometer test

For the masonry compression test, the pocket penetrometer test is used for this study. A pocket penetrometer instrument is a small-sized device that fits in a pocket, and it is a spring-operated device used to evaluate the compressive strength of mortar. This device contains a pushed piston, and the maximum reading is recorded to evaluate mortar compressive strength. Moisture affects the pocket penetrometer test result; hence, accurate results can be obtained by limiting the moisture (18-25%) (Yasun, 2018). Mortar strength at the site is determined by performing the pocket penetrometer test on mortar joints at different building locations. A similar test was performed by Dawid Latka (Łatka & Matysek, 2020) in the historical building, and the test result displayed the result of mortar strength to be 1.4 to 2.9 MPa. The selection of points for the pocket penetrometer test is fixed on the dry surface of the mortar. Test using a pocket penetrometer is conducted by applying pressure at the back of the device on a clear mortar surface, as shown in Figure 10. The reading obtained on the shaft after applying pressure is considered the reading of the pocket penetrometer test. This test is not conducted in the Juddha fire brigade office.

A portable spring-operated device known as a pocket penetrometer is used to evaluate the compressive strength of mortar at the site. Reading is recorded after pushing the piston into the mortar at several numbers of points for the selected seven buildings, as shown in Table 6. The strength of mud mortar captured using a pocket penetrometer is averaged for each building.

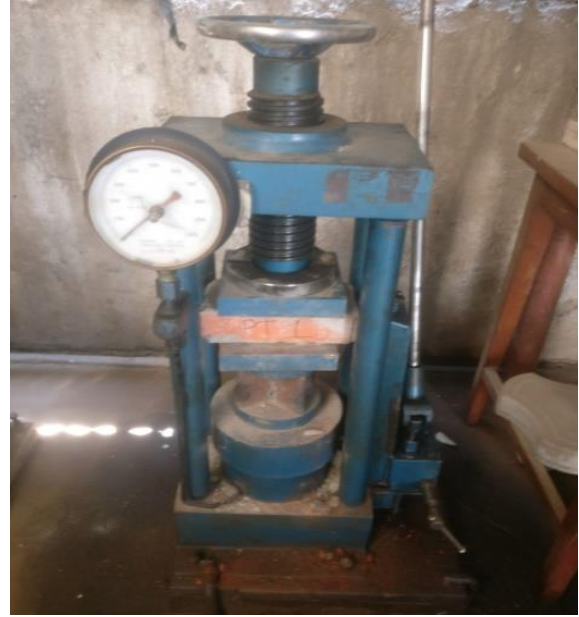
Fig. 11 Brick compression test

After cleaning the selected sample brick extracted from the site, unevenness is removed. The frog portion and voids are filled with 1C:1S (cement and coarse sand of grade 3mm or down) mortar after 24 hours of immersion of brick in water and drain out excess water at room temperature. The jute bag is wrapped in sampled brick for 24 hours. Following the process, the brick is tested after 3 days, as shown in Figure 11.

A brick compression test was performed using CTM with the sample obtained from the site. The number of samples for the test is different due to the authority's permission. The average strength is obtained from the individual building, and the characterized compressive strength of brick is estimated to be 9.09 MPa, as shown in Table 5, obtained by averaging the average of the individual building. The outcome from the compression test on brick is recorded, and the average value is determined for individual buildings under study. The average brick strength in compression varies from 4.5 MPa to 10.18 MPa. It various 8.32 MPa to 9.29 MPa in Kumari Chhe, 8.14 MPa to 10.5 MPa in Patan Darbar, 8.1 MPa to 9.5 MPa in Gopichandra Mahabihar, 8.5 MPa to 9.1 MPa in Napichandra Mahabihar, 7.95 MPa to 10.81 MPa in Keshar Mahal, 8.14 MPa to 9.08 MPa in Babar Mahal, 1.14 MPa to 6.63 MPa in Bagh Durbar, 9.46 MPa to 11.28 MPa in Juddha Fire Brigade as represented in Table 5. The characterized compressive strength of brick is evaluated by averaging the average compression strength obtained from the selected building. The evaluated characterized compressive strength of the brick is 9.09 MPa, as illustrated in Table 5. The compressive strength of brick reported by H. R. Parajuli, 2012 is 11.03 MPa in his case study of the Patan area, whereas R. R. Parajuli et al., 2020 reported brick compressive strength up to 7.64 MPa and Adhikari et al., 2019 in his case study of Bagh Durbar reported as 6.6 Mpa. The close output in a similar case study building demonstrates that the evaluated strength is realistic.
