Fatigue Behaviour of High Velocity Oxy-Fuel Coatings on Medium Carbon Steel

Abstract — Nowadays, the application of high-velocity oxy-fuel (HVOF) thermal spraying coating is widely used in various industries. This is due to its ability to improve the wear, erosion, and corrosion resistance of components. However, by taking consideration of fatigue behaviour into cognisance, the consequence of the HVOF thermal spraying coating on the components remains debatable. In this research, the fatigue behaviour of the uncoated steel, WC-12Co coated steel, and WC-10Ni coated steel were investigated. At first, the tensile test was conducted on the S50C steel to determine its yield strength. The yield strength was then being applied as a benchmark in a staircase method to set the stress amplitudes for the fatigue test. Fatigue tests were performed under the stress ratio, $R=-1$, by tension-compression cyclic loading (sine wave) with a frequency of 20 Hz according to ASTM-E466. The results showed that the HVOF decreased the tensile and yield strength by 8.9% and 9.5%, respectively. Similar behaviours are shown by the fatigue properties, as the HVOF coated steel reduced the fatigue strength's by

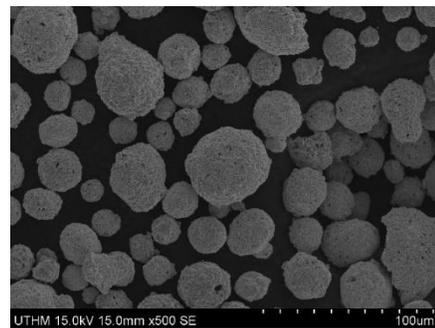
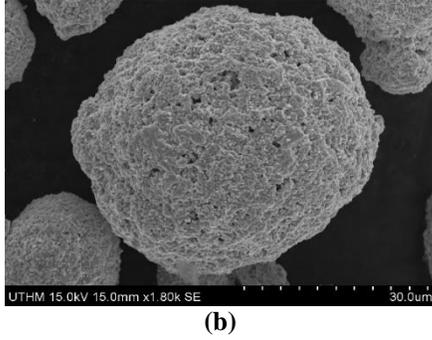
Fig. 5: The micrograph image of WC-12Co powder with a magnification of; (a) 500x, (b) 1800x

The detailed powder manufacturing method affects the powder characteristics such as particle shape, structure, and size, powder density, flowability, purity, phase content, etc. The SEM micrographs of WC-12Co powder and WC-10Ni powder can be seen in Figure 5 and Figure 6. Both powders showed an identical microstructure, consists of small spheroidal evenly distributed particles. This proved that both powders are agglomerated and sintered powders.

According to B. Wielage *et al.*, granules morphology analysis for agglomerated and sintered powder revealed that they are characterized mostly by a spherical shape, whereas sintered and crushed powder are characterized mostly by irregular shape, where it has poorer flowability compared to spherical shaped powder [27].

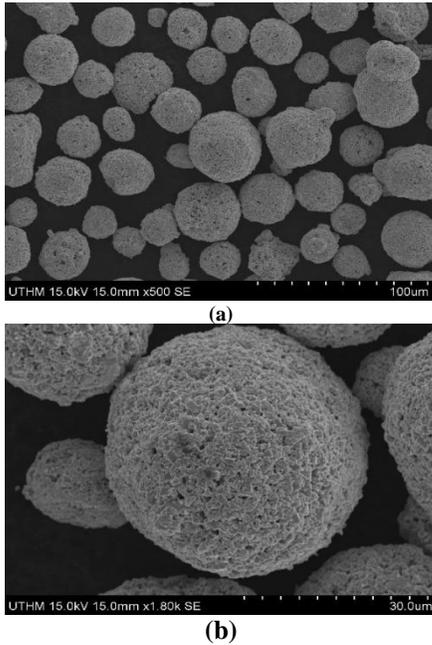
Fig. 6: The micrograph image of WC-10Ni powder with a magnification of; (a) 500x, (b) 1800x

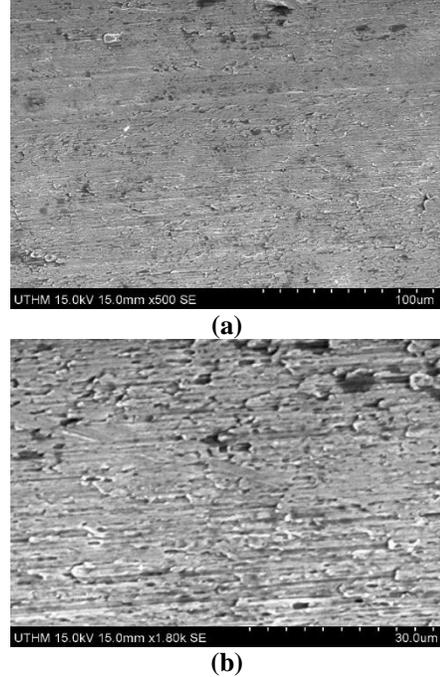
Fig. 7: The micrograph image of S50C steel with a magnification of; (a) 500x, (b) 1800x

Fig. 7, Fig. 8, and Fig. 9 display the surface morphology of the S50C steel substrate, WC-12Co coatings, and WC-10Ni coatings. It showed that the distribution of tungsten carbide (WC) consists of an angular shape and, in light contrast, dissolves into a metallic binder of Co and Ni, which is in dark contrast. During the HVOF process, WC carbide grain is preferentially melted in both binder phases at high temperatures [28]. According to J. M. Guilemany *et al.* [29], the heating process above the melting point of the powder is the main factor for the molten WC to dissolve binder matrix Co and Ni rapidly, forming CoWC and NiWC liquid alloys.

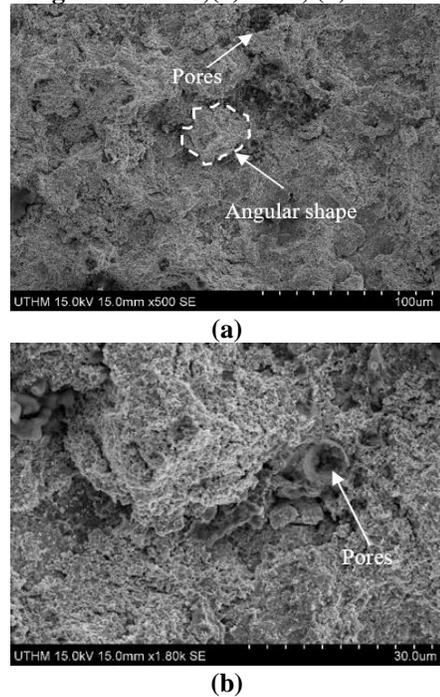
Fig. 8: The micrograph image of WC-12Co coating with a magnification of; (a) 500x, (b) 1800x

Pores have been observed on the coating's surface due to the random build-up, curling up, and incomplete filling of splats' interstices during the thermal spray process. This will degenerate the bonding strength, accommodate deformation, accelerate crack propagation and worsen the mechanical

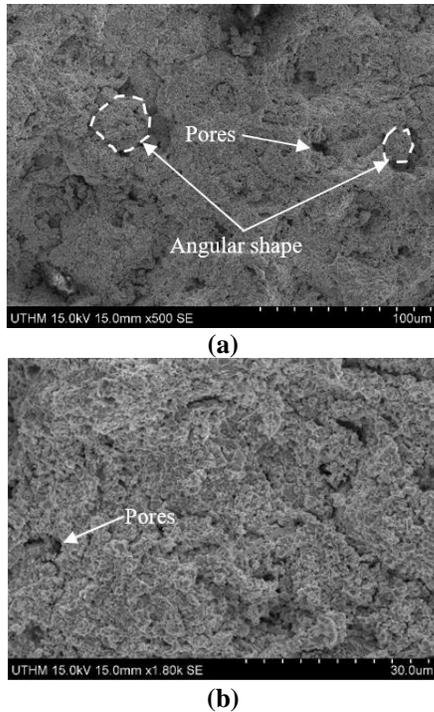
Fig. 9: The micrograph image of WC-10Ni coating with a magnification of; (a) 500x, (b) 1800x

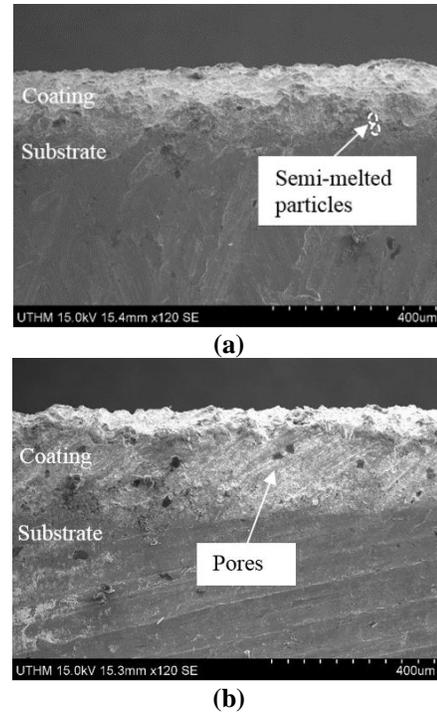
Fig. 10 shows the cross-sectional micrograph of the WC-12Co and WC-10Ni coatings observed by SEM. Strong adhesion between the dense coating layer and the substrate was revealed in the cross-sectional micrograph. However, some extreme plastic deformation and swift solidification are followed by the high-velocity effect of coating powders on the substrate's surface. The coating layers are also likely to have unavoidable pores and cracks. [32]. According to N. W. Satya [33], on the coated steel, a common 1.89 percent porosity was identified, and the unbonded interface between the coating and the substrate was around 38 percent long. Cracks were also found on the substrate's surface, which caused not only by the high impact of powder particle, but it also caused by the grits from grit blasting treatment.

Fig. 10: The cross-sectional micrograph image of; (a) WC-12Co coating, (b) WC-10Ni coating with a magnification of 120x

From the observation, both coatings consist of a lower number of pores and semi-melted particles. The presence of semi-melted particles is due to the HVOF spraying process, where the powdered particles experienced thermal and kinetic history, causing the particles to impinge on the substrate in partially molten or fully molten [34]. M. Jadidi [35] supported that velocity, trajectory, temperature, and melting state, have a tremendous influence on the coating properties. Clearly, by HVOF, a low flame temperature and very high particle velocity caused the presence of semi-molten particles.

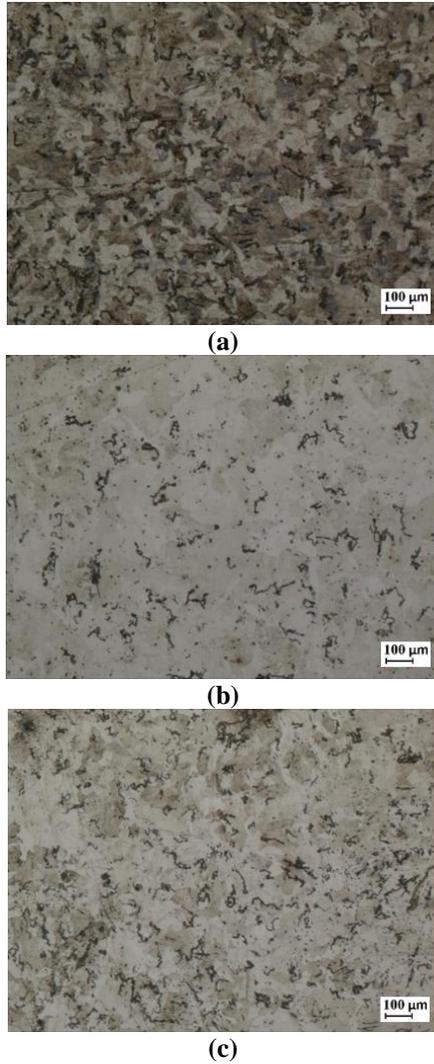
There was an increment of grain size by the substrate at the WC-12Co and WC-10Ni coated steel, as in Fig. 11. The average grain size of the uncoated steel was 40.3 μm . Meanwhile, the average grain size at the substrate of the WC-12Co and WC-10Ni coated steel increased to 61.3 μm and 60.3 μm , as in Fig. 12. These growths of the grain are mainly due to the high-temperature effect (2750°C) from the HVOF thermal spray process, which alters the original grain size of the S50C substrate. According to Callister and Rethwisch [36], if the material is left at an elevated temperature, the grains will begin to grow. The total boundary area decreases as grains increase in size, yielding a concomitant decrease in the total energy; this is the driving force for grain growth. Heat treatment also provides an effective way to manipulate the properties of the metal by regulating the rate of diffusion and the rate of cooling inside the microstructure, according to Zia *et al.* [37]. The mechanical properties of a metallic alloy can be altered by heat treatment, which manipulates properties such as hardness, strength, ductility, and elasticity.

Fig. 11: Grain micrograph image of; (a) uncoated steel, (b) WC-12Co coated steel (at substrate), (c) WC-10Ni coated steel (at substrate)

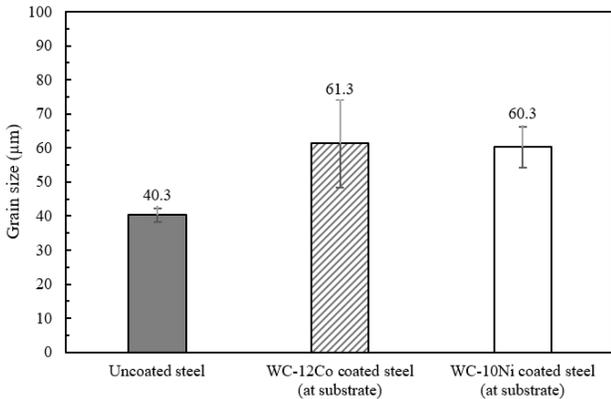
Fig. 12: Grain size for uncoated steel, WC-12Co coated steel (at substrate), WC-10Ni coated steel (at substrate)

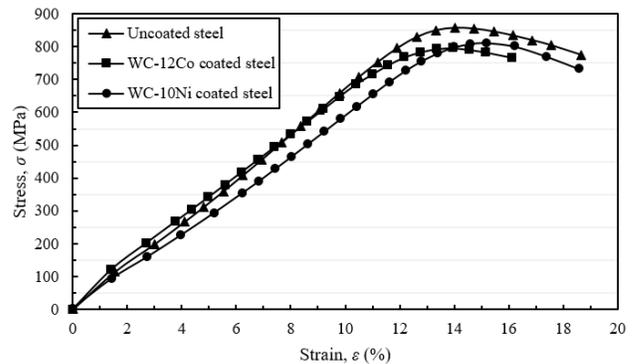
The load versus elongation curve was converted into a stress-strain curve by taking into consideration the additional thickness and cross-sectional area of the coating deposition, with overall stress calculated by the instantaneous load over the initial area, as in Fig. 13. By comparing the coated steel with the uncoated steel in Table III, the WC-12Co coated steel (782 MPa) and WC-10Ni coated steel (825 MPa) have a lower tensile strength value compared with the uncoated steel (858 MPa). Similar to the yield strength properties, the value of the yield strength is lower on the WC-12Co coated steel (766 MPa) and WC-10Ni coated steel (821 MPa) compared to the uncoated steel (846 MPa). This showed that the impact of the HVOF process lowered the S50C steel's tensile strength and yield strength.

Fig. 13: Stress-strain curves of uncoated steel, WC-12Co coated steel, and WC-10Ni coated steel

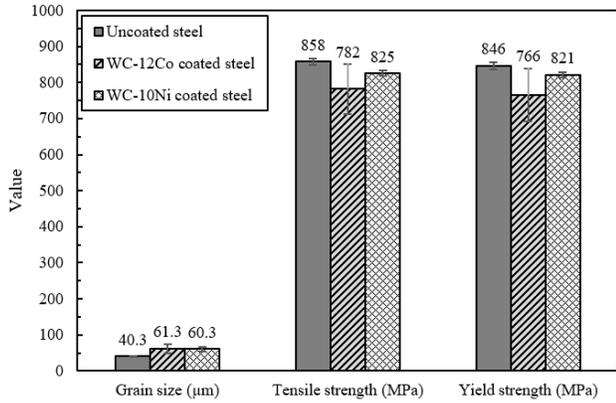
The decrement of tensile strength and yield strength was because of the hardening effect, specifically, the increment of the grain size at the substrate's surface, as in Fig. 14. The increment is due to the 2750°C high-temperature effect of the HVOF process, which was directly sprayed onto the substrate's surface. As the grain size grew, the number of dislocations stacked up at the grain boundary was affected, as the grain boundary served as a dislocation motion barrier. The coarser-grained material has a smaller total grain boundary area to hinder dislocation movement; thus, the coarse-grained material is weaker than the fine-grained material. This has made the coarse-grained material less resistant to plastic deformation, resulting in lower tensile and yield strength values [36].

Fig. 14: The relation between grain size, tensile strength, and yield strength

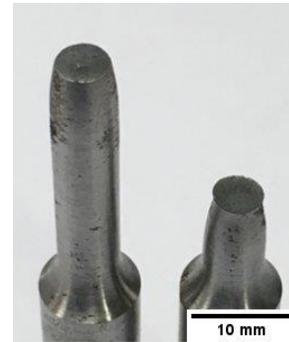
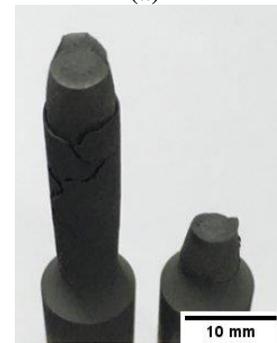
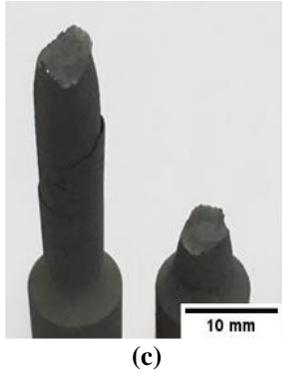
A moderate amount of necking, followed by the formation of voids, cracks, and shears, precedes fractures in the most ductile metal. This gives the uncoated steel and coated steel with WC-12Co and WC-10Ni coatings the characteristic cup-and-cone fracture, as in Fig. 16. There is also irregular and fibrous appearance in the central interior region, as shown in Fig. 17, which implies that there had been mechanisms of plastic deformation [38].

Fig. 16: The fractured surface of; (a) uncoated steel, (b) WC-12Co coated steel, (c) WC-10Ni coated steel

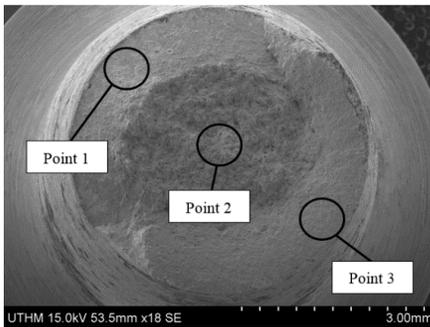
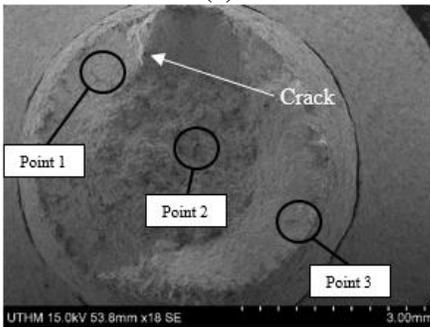
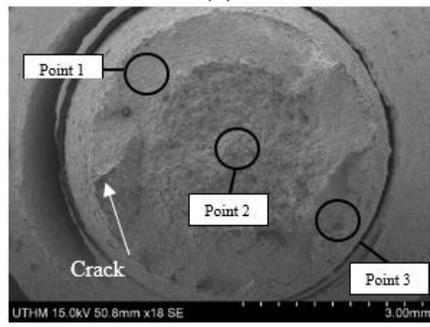
Fig. 17: The fractured surface of; (a) uncoated steel, (b) WC-12Co coated steel, (c) WC-10Ni coated steel with a magnification of 18x

On the other hand, a visible crack can be seen at the outer region, Point 1 and Point 3 of the fractured steel for both WC-12Co and WC-10Ni coated steel in Fig. 17(b) and Fig. 17(c). This indicates that cracks may be nucleated at the surface of the substrate, Point 1 and Point 3, and transversely propagated inside the central region, Point 2. In previous research, the cracks are thought to be heterogeneously nucleated at sites where further deformation is difficult and consists predominantly of foreign inclusions [38].

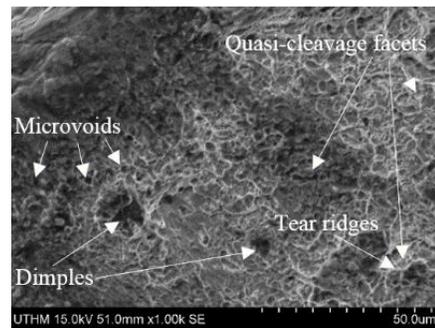
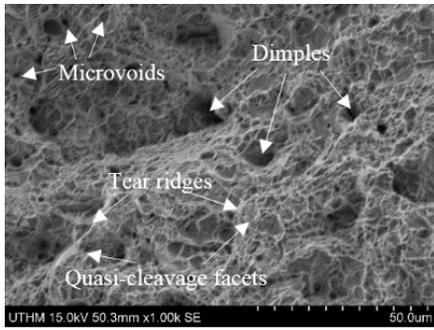
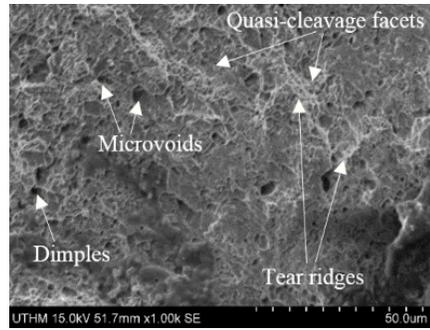
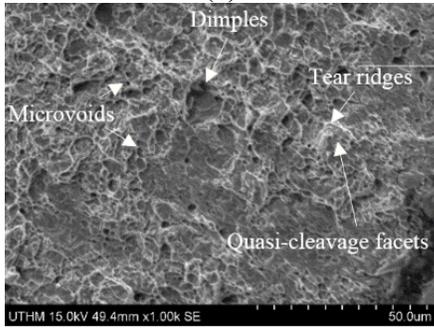
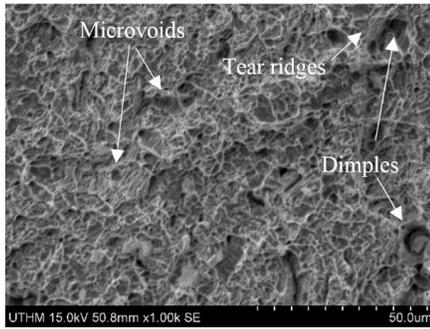
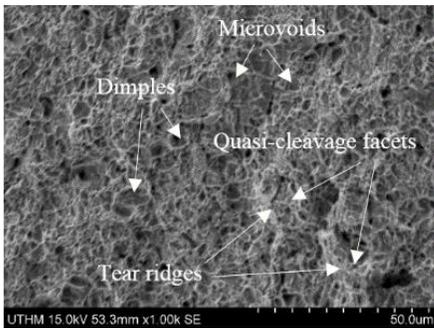
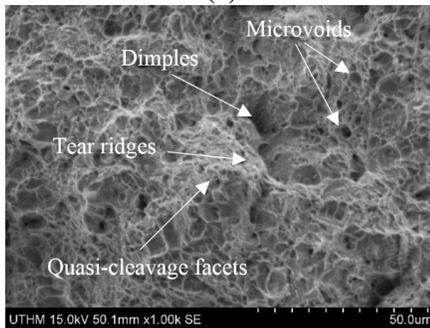
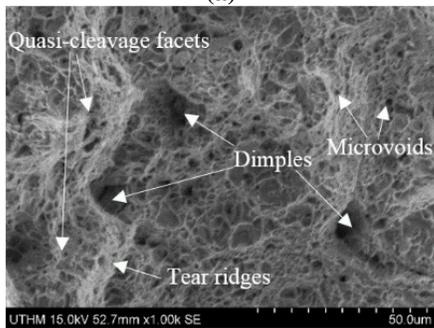
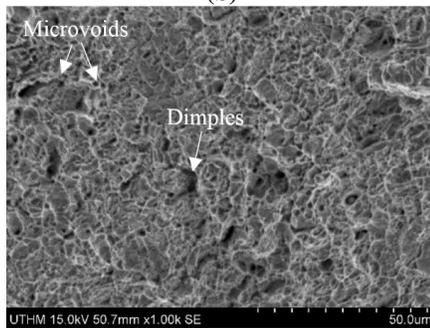
Analysis of the results from SEM shows that both uncoated and WC-12Co/WC-10Ni coated steel showed no significant difference on the fractured surface. Fig. 18, Fig. 19, and Fig. 20 represent the SEM images of the fractured tensile specimen at different points (Point 1, Point 2, and Point 3), as labeled in Fig. 17. The detailed view of the fractured surface is characterized by the microvoids, tear ridges, transgranular ductile dimples, and transgranular quasi-cleavage facets. However, the fractured surface mainly consists of ductile dimple tearing, a consequence of the microvoid coalescence and few percentages of transgranular quasi-cleavage facets. Nonetheless, the overall fracture occurred in a transgranular manner, as most cracks are propagated through the grains.

In the detailed view, Point 2 of both coated and uncoated steel show a higher number of ductile dimples compared with other points. This indicates that the ductile fracture mechanism, which is characterized by a considerable amount of plastic deformation before and during crack propagation, occurred at the center of the specimen (Point 2). With respect to tensile loading, Pandey *et al.* [39] stated that the coalescence of microvoids results in equiaxed dimples on the surface of ductile tensile fracture normal to the loading axis. Therefore, on a flat crater bottom-loaded by tension, it reveals the equiaxed and spherical dimples and elongated ellipsoidal dimples on the shear lips oriented at 45°.

The amount of nonlinear nature of microscopic cracks intermingled with pockets of cleavage facets was increased in the outer region, either Point 1 or Point 3 compared to Point 2. The cleavage facets indicate that “locally” brittle fracture mechanism, which is characterized by micro-deformation or no gross deformation during the crack propagation, occurs at these regions. The small region of the tensile specimen fractured in a brittle manner due to the inability to withstand the very high tensile load, resulting from the low-stress area. According to Yan and Zhao [40], as the stress increases during tensile loading, the cross-sectional area is reduced, and the necked region is produced. Upon observation on the fracture surface comparison, with ductile behavior shown, there is a considerable amount of stress caused where cracks propagated until failure.

Fig. 19: The fractured surface of WC-12Co coated steel with a magnification of 1000x at; (a) Point 1, (b) Point 2, (c) Point 3

Fig. 18: The fractured surface of uncoated steel with a magnification of 1000x at; (a) Point 1, (b) Point 2, (c) Point 3

Fig. 20: The fractured surface of WC-10Ni coated steel with a magnification of 1000x at; (a) Point 1, (b) Point 2, (c) Point 3

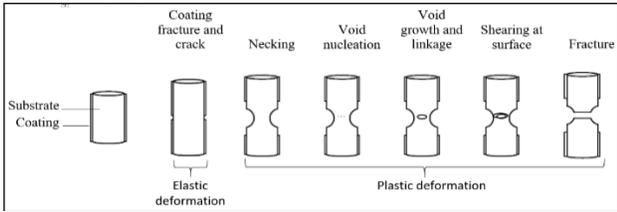
As by coated steel, the presence of foreign inclusion contains coating and grit particles on the substrate's surface, resulting in crack deformation at the outer region. These cracks will then be propagated inside the central region. At the same time, a localized reduction in the cross-sectional area, called necking, occurred. After that, numbers of microvoids, cracks, and dimples formed, which then formed a crack growth from the central region at Point 2 outwards perpendicularly to the stress application. Finally, a rapid crack propagation at about 45° to the tensile axis leads to a total brittle fracture. Fig. 21 shows the flow of the fracture mechanism [38].

Fig. 21: Schematic diagram of the ductile tensile fracture mechanism

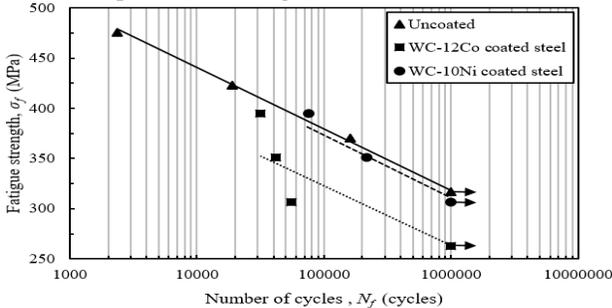
Based on Table IV shows that the uncoated steel has the highest fatigue strength (317 MPa at 10⁶ cycles), followed by WC-10Ni coated steel (307 MPa at 10⁶ cycles) and WC-12Co coated steel (263 MPa at 10⁶ cycles). Similar to the lines in Fig. 22, it showed that the uncoated steel's line is located uppermost, followed by WC-10Ni coated steel and WC-12Co coated steel, which explained that the uncoated steel has the highest fatigue strength, followed by the coated steel. Besides that, all lines are parallel to each other proved that no external factors such as temperature, corrosion, etc., affected the specimens during the test.

Fig. 22: The stress-life (S-N) diagram of uncoated steel, WC-12Co coated steel, and WC-10Ni coated steel

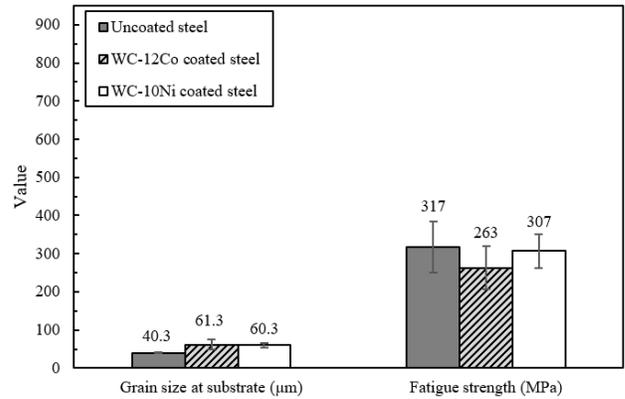
From Fig. 23, the fatigue strength of WC-12Co coated steel is decreased by 17%, whereas the fatigue strength of WC-10Ni coated steel was decreased by 3.2%. The decrement was due to the 2750°C high-temperature effect of the HVOF coating process directly sprayed onto the substrate's surface, which enlarged the size of the grain. As the grain size enlarged, it increased localized strain along with slip bands, increasing the amount of irreversible slip and provide fewer grain boundaries to aid in transcrystalline crack arrest and deflection, thus raising the growth rate of fatigue crack [41].

Fig. 23: The relation between grain size and fatigue strength

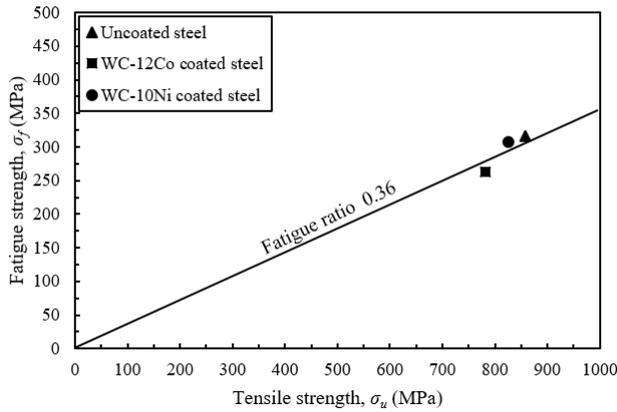
In this research, the relationship between fatigue strength and tensile strength can be illustrated in Fig. 24. It shows that the fatigue strength increases correspondingly toward the tensile strength. Also, the averaged fatigue ratio, σ_f/σ_U value, was at about 0.36, which is, however, lower compared to the expected value, 0.5.

Fig. 24: The relation between fatigue strength and tensile strength

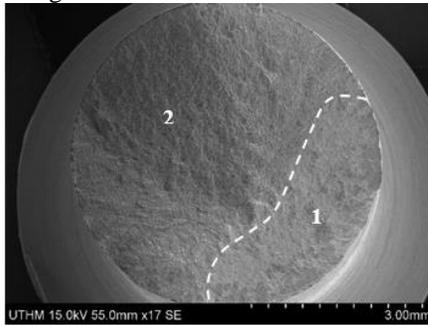
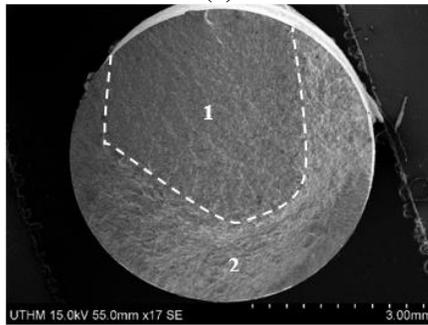
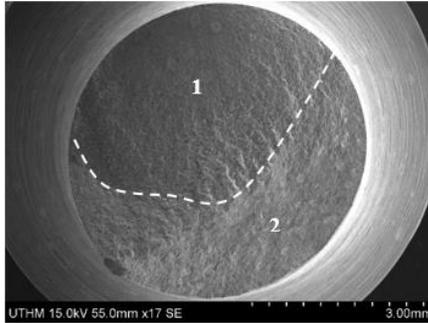
Fig. 25(a), Fig. 25(b), and Fig. 25(c) show the same type of specimen, uncoated steels, which were applied by different stress amplitudes of 10.5 kN, 12 kN, and 13.5 kN. In comparison, the fractured surface from the higher stress amplitude of 13.5 kN showed a smaller burnished, smooth region and a larger granular, rough region, compared to the lower stress amplitude of 10.5 kN and 12 kN. According to past researchers [45,46], a larger percentage of the cross-section showed fatigue crack growth if lower nominal stress was likely applied to the material. However, a smaller percentage of the surface shows fatigue crack growth if higher nominal stress was likely applied to the material. Besides the magnitude of the applied stress, the stress concentration (notch) and fracture toughness of the material also play a similar role to the cross-section’s percentage of the crack surface.

Fig. 25:The fractured surface of uncoated steel with a magnification of 17x at a stress amplitude of; (a) 13.5 kN, (b) 12 kN, (c) 10.5 kN

The fractured surface can be seen to have two distinct regions, which are burnished, smooth or granular, rough regions. In Fig. 25, Fig. 26, and Fig. 27, the burnished, smooth region was labeled as 1, while the granular, rough region was labeled as 2. The burnished, smooth region is the region where the fatigue crack took place. It consists of cracks initiation, progression mark, clamshell pattern, benchmark, and striation. On the other hand, the granular, rough region is the region where the final ductile fracture occurred. In a fatigue cycle, the final ductile fracture region underwent a fracture in a shorter period compared to the fatigue crack region [44].

Fig. 25(b), Fig. 26(b), and Fig. 27(b) show different types of specimens; uncoated steel, WC-12Co coated steel and WC-10Ni coated steel, which was applied at the same stress amplitude of 12 kN. From the observation, the uncoated steel shows the largest burnished, smooth region compared to the WC-12Ni coated steel and WC-12Co coated steel. This is because the notch surface formed by the coated steel due to the HVOF process caused a higher stress concentration and lead to a faster fracture. According to L. O. A. Affonso [46],

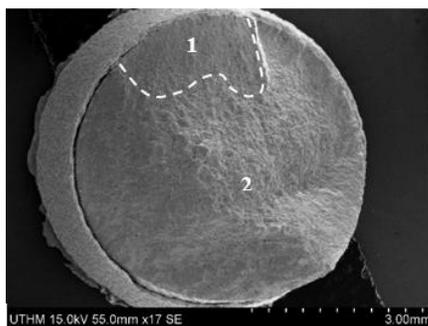
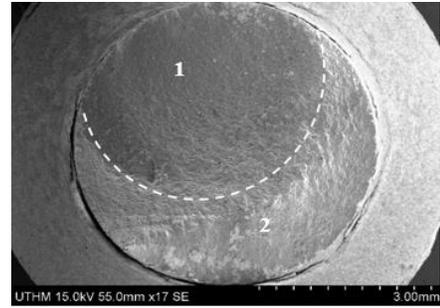
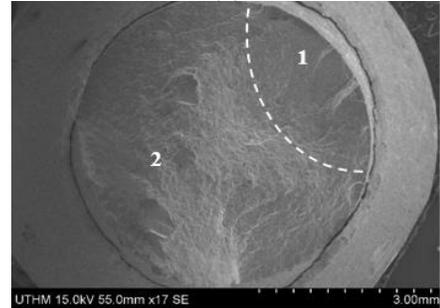
Fig. 26:The fractured surface of WC-12Co coated steel with a magnification of 17x at a stress amplitude of; (a) 13.5 kN, (b) 12 kN, (c) 10.5 kN

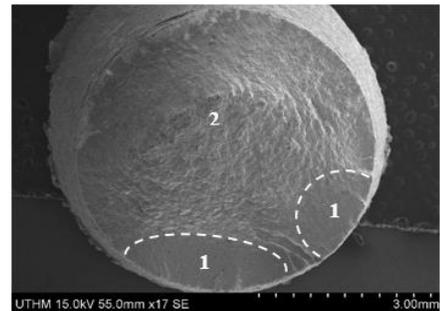
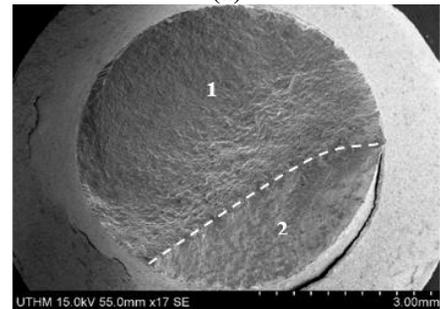
Fig. 27:The fractured surface of WC-10Ni coated steel with a magnification of 17x at a stress amplitude of; (a) 13.5 kN, (b) 12 kN

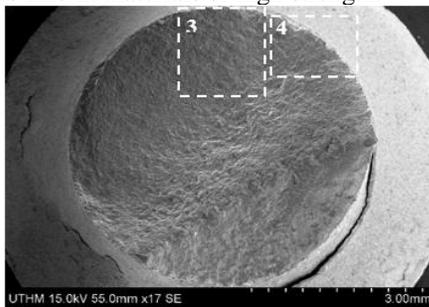
Fig. 28 shows the fractured surface of WC-10Ni coated steel with a magnification of 17x at a stress amplitude of 12 kN; meanwhile, Fig. 29 and Fig. 30 represent the higher

Fig. 28:The fractured surface of WC-10Ni coated steel with a magnification of 17x at a stress amplitude of 12 kN

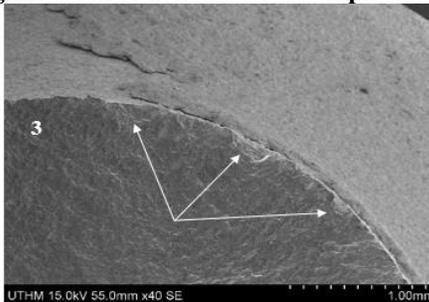
magnification (40x) image at certain regions, labeled as 3 and 4. From Fig. 29, many initial cracks can be seen near the upper right outer perimeter. These are shown by somewhat radial lines, often called “ratchet marks”, extending around the upper left perimeter. The initial cracking process began at the surface and then propagated towards the inside of the specimen. According to G. A. Pantazopoulos [47], cracks usually nucleate at or near-surface because inelastic deformation is easier at the surface. Intrusion or extrusion develops on the surface, stresses or strains from external loads are usually greatest on the surface, while stress concentration from manufacturing processes often exists on the surface, and environmental attacks such as corrosion occur on the surface. However, cracks can also nucleate at non-surface areas such as at grain boundaries, inclusions, pores, and other microstructural features or discontinuities.

Fig. 29:Fatigue initiation at the fractured surface of WC-10Ni coated steel with a high magnification of 40x at a stress amplitude of 12 kN

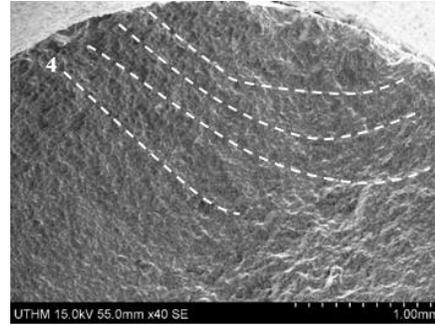
From Fig. 30, fatigue striation (microscopic characteristics) is observed on the fractured surface, which indicates the progression of the fracture at each load cycle. It shows the incremental growth of a fatigue crack. However, fatigue striations are not beach marks (progression marks). Beach marks (macroscopic characteristic) are produced by modification of the stress that causes the progression of the crack tip. The progression marks indicate that the fracture progression occurs in a direction that changes somewhat from time to time. Besides that, one beach mark can contain thousands of striations [48]. These striations may not be seen clearly because of significant surface rubbing and pounding during repetitive loading. They are also very nearly impossible to find in materials of high strength.

Fig. 30: Fatigue striation at the fractured surface of WC-10Ni coated steel with a high magnification of 40x at a stress amplitude of 12 kN

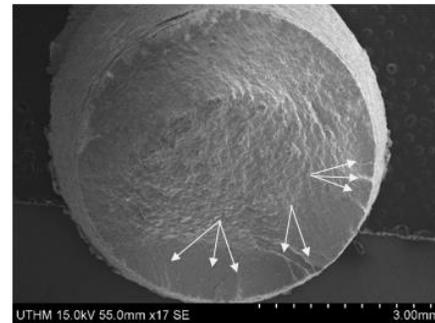
With reference to Fig. 31, multiple crack initiations in different regions could be observed. According to J. G. La Barbera-Sosa *et al.* [7], the multiple crack initiations were due to the notch or cracks formed by the high-velocity impact of the powder particle from the HVOF process. The notch and cracks produced at the periphery of the substrate encourage multiples of crack initiations to occur.

Fig. 31: Multiple crack initiation at the fractured surface of WC-10Ni coated steel with a magnification of 17x at a stress amplitude of 13.5 kN
