# Scientific Study of Asphalt Road Surface Distress and their Role in the Design of Flexible Pavements

**Abstract** - Identifying the various locations, magnitude, and frequency of pavement distresses on the highway stretch under study. Examining the total pavement failure, distress, and individual weightage percentage, analyzing and reviewing the role of pavement distress in the design of asphalt pavement were the main objectives of the study. The forensic investigation of the selected road stretch was carried out through the experienced engineers engaged in the road construction and maintenance activity by data collection, interaction with the public, and employees familiar with the road, non-destructive evaluation by a primary site visit, condition Survey, visual investigations, etc. As per the present study of National Highway No.61, India, longitudinal cracking, ravelling, rutting, patches, and fatigue cracking are predominant, with their distress percentage as 32.71, 21.5, 19.82, 19.15, and 4.23, respectively. These five distress accounted for 97.41% of the weightage in bituminous pavement failure. Longitudinal cracking and ravelling are found to be predominant and such type

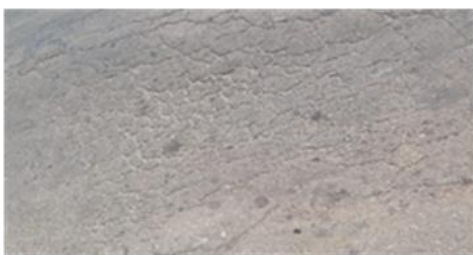
Alligator or fatigue cracking is the most frequent structural distress in asphalt pavements with granular and poorly maintained bases, and it is produced by fatigue degradation, as shown in Figure 1. Alligator cracking starts as parallel longitudinal fractures in wheel paths and evolves to a network of interconnected cracks that looks like alligator skin or chicken wire.

**Fig. 1 Fatigue (alligator) cracking**

Inadequate structural support, which can be caused by several things, is the possible cause of Fatigue cracking. A few of the more common ones are enlisted here; Loss of base, sub-base, or sub-grade support ( e.g. improper drainage or spring thaw resulting in poor stiff base), Construction flaws (e.g. Inadequate compaction), Decrease in pavement load support characteristics, Loading increase (more than design load), and Stripping on the HMA's bottom layer (surface layer) (the stripped portion contributes little to the pavement strength, so effective HMA thickness decreases).

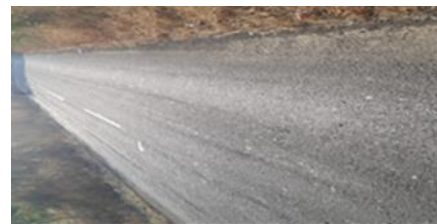
Rutting is a production of the longitudinal recessions in the wheel paths, which is usually affected by material movement or consolidation in the subgrade and base, as well as the asphalt concrete layer. Abrasion by studded tires and tire chains is another independent cause of rutting.

**Fig. 2 Rutting**

Consolidation or plastic flow is the cause of deformation that occurs only later in the asphalt concrete. After construction, traffic loads continue to compact the asphalt concrete, resulting in consolidation, as shown in Figure 2. Consolidation can cause severe rutting in very thick asphalt layers that are compacted to initial air void contents that are significantly greater than the air void long-term contents for which the blends were designed. The stiffness of cement asphalt is thought to play a minimal role in the resistance rutting of asphalt mixes containing angular, rough-textured, well-graded particles. Rutting occurs in overlays asphalt on concrete pavements because of shear stress caused by applied stresses causing the mix to flow laterally away from the wheel paths. Asphalt shear stress is maximum for thicknesses overlay of 4 to 6 inches when the asphalt and concrete are not connected [16]. Premature rutting, which happens in an insufficiently designed mix because of shear failure, develops abnormally quickly and reaches a critical level within one or two years.

The numerous reasons for rutting may be summarized as follows: The coarse aggregate, sub-base, granular base, lower layers, or any composite of such pavement layers is not stable enough. The subgrade or any of the pavement structures have not been adequately compacted and Improper design creating substantial vertical stress on the subgrade. The channelized flow of large wheel loads

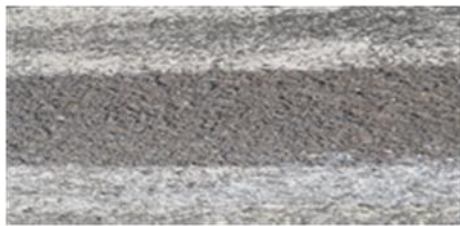
Ravelling is the gradual deterioration of the concrete asphalt surface instigated by the loss of aggregate and bitumen binder particles from the downward surface. This can be caused by the dust on the aggregate interfering with adhesion asphalt, asphalt cement hardening, isolated pockets of segregation in the concrete mix asphalt where fine aggregate particles are missing, or a low in-place mix density due to poor compaction.

**Fig. 4 Ravelling**

Ravelling also includes aggregate dislodging and surface softening as a result of oil spillage, as shown in Figure 4. Ravelling and weathering can be dangerous if water collects in degraded portions of the surface, causing hydroplaning or wheel-spray. A potential safety issue is a loose material on the pavement surface that could be scooped up by vehicle tires [19].

Ravelling measures the affected area in square meters. Chip seals should not be used to rate ravelling. The entire area covered up for surface defects ravelling at 24 locations is 1769.6 sqm which is 21.50 per cent of total surface failure (Refer Table 3).

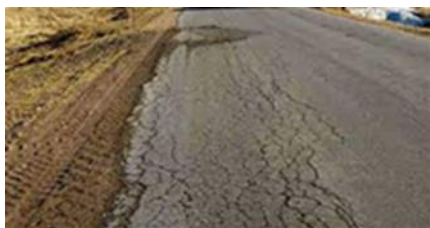
The cracking of the asphalt pavement into the rectangular chunks ranging in size from 1 to 10 feet on a side is known as edge cracking. Edge cracking occurs on large paved surfaces such as parking spaces and streets, particularly in places that are not subjected to the traffic loads, but it can also occur in heavily trafficked locations, as shown in Figure 5.

**Fig. 5. Edge cracking**

The use of asphalt cement that has grown too strong for the climate causes both thermal cracking and edge cracking. The key to minimizing thermal and edge cracking is to choose the asphalt cement with a low stiffness that is not sensitive to temperature [20].

In Edge cracking filling low-severity fractures is one of the restorative procedures. Patches and repair of distressed regions may be required as the severity of the condition worsens. In all circumstances, excessive moisture should be removed, and the shoulders should be rebuilt using high-quality materials.

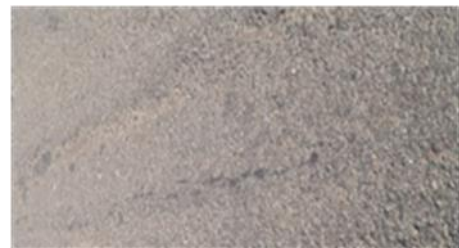
In regions where vehicles do not run smoothly, i.e., use of breaks, slippage cracking happens because of the low-strength asphalt mix in the surface layer and/or a poor link between the underlying layer and the surface layer, as shown in Figure 6. As a result, slippage cracking is unusual on highway pavements, but it is frequent on streets and local roads, especially near the intersections [21].

**Fig. 6. Slippage cracking**

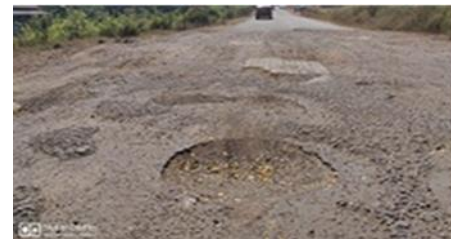
A pot-hole is a bowl-shaped form that appears in the layers of pavement asphalt surface or structure, ranging in diameter from 6 inches to 3 feet, as shown in Figure 8. When traffic wheels displace fragments of asphalt concrete, such as in alligator-cracked areas, potholes emerge. Like water gathers in the hole and seeps into base and subgrade, potholes expand in size and depth, decreasing stability in the area [5].

**Fig. 8 Pot-hole**

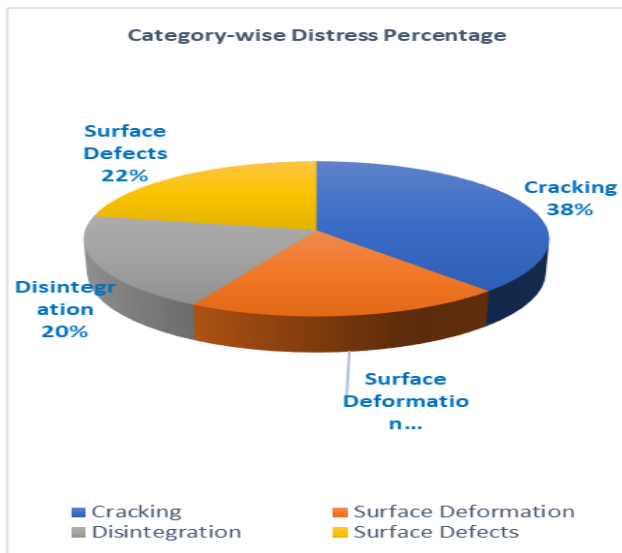
Figure 9 Pie Chart shows the pictorial representation of category-wise pavement distress.

**Fig. 9. Category-wise distress percentage**

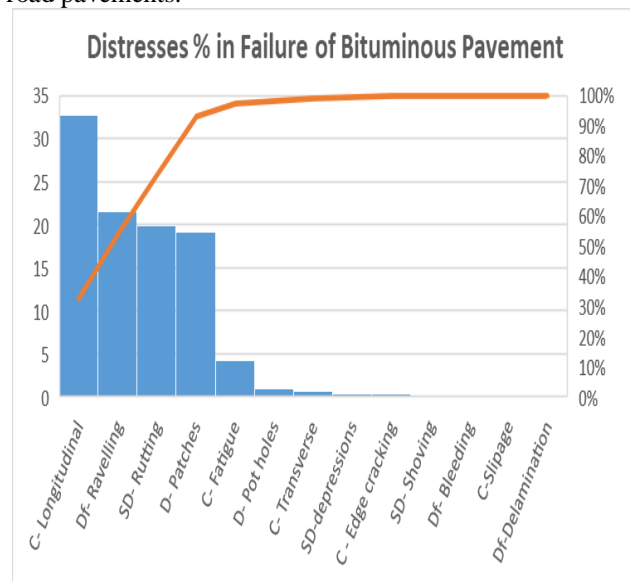
As a graphical representation of the analysis, Figure 10 presents a Pareto Chart, which represents individual percentages of different distresses with sky blue bars and cumulative percentage distresses by an orange line. It is easily analyzed that longitudinal cracking, ravelling, rutting, patches, and fatigue cracking have a major contribution (97.41%) in the failure of bituminous road pavements.

**Fig. 10. Pareto Chart- Weightage of different pavement distress**

According to this data, longitudinal pavement distress has the largest weightage of pavement distress on the National Highway, accounting for about 32.71 per cent. Ravelling, rutting, patches, and fatigue cracking has pavement distress of 21.5, 19.82, 19.15, and 4.23 per cent, respectively. These five distresses accounted for 97.41% of the weightage in bituminous pavement failure.
