# Interpretation of Modified Shear Failure in RC Beams

Present study describes an investigation into the causes of shear failure of reinforced concrete beams subjected to two point loading with shear span/depth ratio greater than 2.5. In this investigation tests are carried out on four reinforced concrete beams labelled as B1, B2, B3 and B4 are identical in geometry, flexural reinforcement, material properties and test details. The only variable is shear stirrups spacing along the member length. Strength and performance of beams with various arrangements of stirrups are verified. An experimental study of beams with various arrangements of shear stirrups has indicated that the predicted behaviour is incompatible with the concept of shear capacity at critical sections that forms the basis of current shear design procedures. The results obtained support the view that shear failure is associated with the development of tensile stresses within the compressive zones of the beams.

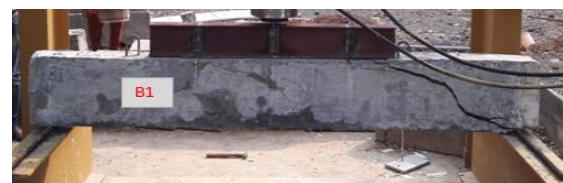
Specimen B1 after testing

Figure 5: Beams B1, B2, B3 and B4 after testing

In beam B1, the initial crack originated was shear at the support of the side face at 44kN-m, which was 73.3% of ultimate moment. With load increased, diagonal cracks formed in the shear span on either sides of the load on the side faces. The shear failure occurred suddenly at moment 60kN-m. Increases in load extended the diagonal cracks to the top face and the crack width widened. With slight shear compression distresses on the top face. In beam B2, stirrups provided throughout length of the span, initial crack is appeared at the near to support of the side face at 40kN-m, which was 48% of ultimate moment. As the load increased, several diagonal cracks formed in the shear span on either side of the load on the side faces, and extended towards the top face. Ultimate shear force failure occurred at moment 84kN-m. In beam B3, initial crack is appeared at the support of the side face at 48kN-m, which was 71% of ultimate moment. As the load increased additional diagonal cracks formed and those already formed extended towards the top face, the crack widths widened. Ultimate shear failure occurred at 68kN-m. The beam B4, stirrups provided throughout length of the span and except at 2d from the support, initial crack is appeared at the near to support of the side face at 40kN-m, which was 45% of ultimate moment. As the load increase, several diagonal cracks formed in the shear span on either side of the load on the side faces, and extended towards the top face. Ultimate shear force failure occurred at moment 88kN-m. Comparison between theoretical and test strengths of beams B1, B2, B3 and B4 are represented in Table- 4.

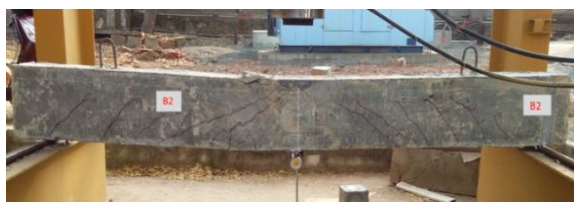
Specimen B2 after testing
