Experimental Analysis Through Design Optimization for DFM and weight Reduction of Gear shifter Diff-Lock Fork of Transmission System of Commercial Vehicles

Abstract

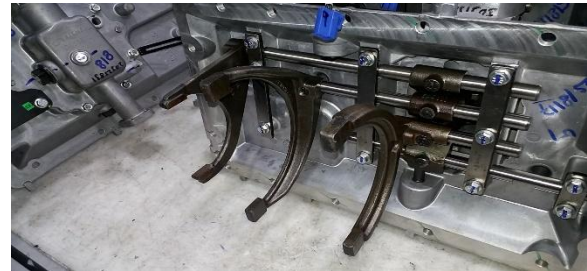
Figure 1: Fork

The fork of the car is one of the key parts of the car speed shifting system playing an important role in shifting the speed and changing the direction. The fork could move the ring gear of synchronizer to separate and unite thus the speed shifting is achieved. As a part of the car the fork has a bearing on the safety of the car and person. The clear speed gear and the smooth transition have always been the objective of the transmission control facility design and important index for evaluation of good transmission. The ingenious and flexible control facility could not only improve the comprehensive function of the transmission but also promote the comfortable feeling of driving and riding.
