Structural Audit of a Heritage Structure: A Case Study

Abstract

A visit was planned on 4 March, 2017 to have a reconnaissance survey for the investigation of the rock from Alandi Temple - Shree Dnyaneshwar Maharaj Samadhi Mandir. Alandi (18°40'37.42"N 73°53'47.76"E) is located on the holy banks of the Indrayani River, 20 km north of Pune. The studies of the petrographic rocks was carried out for some specimens of the temple and are assumed to be the representative of the whole temple. The samples collected were from the nearby vicinity of the temple and within the temple region like the Mahadwar, second door entrance of temple, some newly constructed region within temple, outside the temple and the temple from ghat region.

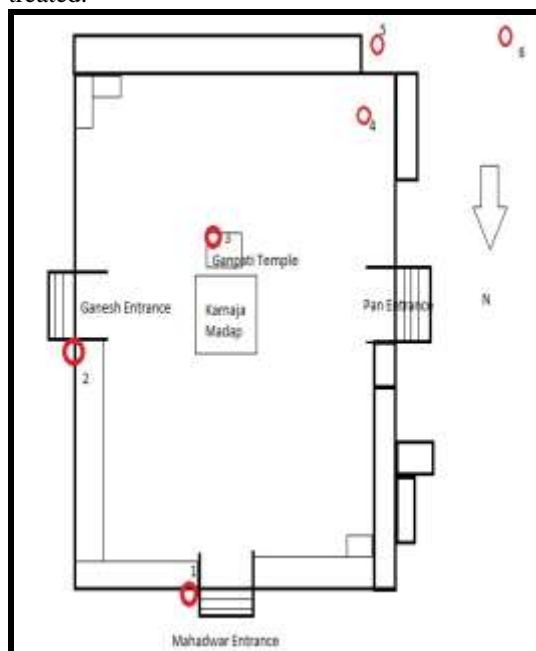
Sample Selected Map

- All the specimens studied under microscope show good relationship for bounding nature of minerals.
- The rocks which are collected are yet in good condition as a building material.
- The weathering effect shown by the rocks is too slow
- Respective mineral composition (microscopic) is enlisted for every specimen except the Mahadwar specimen.
- Mineral association with respect to their textural association is hugely bounded, Cleavages within the minerals are observed but has no relevance to weathering.
- Structures exhibited by the minerals are clear and has good bounding so the rock remains yet in good condition.
- The walls of the temple towards the Pan entrance and towards the shops attached to the temple are being loosen and needs to be treated.

- To understand the exact composition the geochemical studies should be done for these samples.

- The weathering effect shown by the rocks is too slow but there should be treatments provided to the temples from the ghat sections to avoid the erosion of the rocks due to water body from the river channel.
- The walls of the temple at various location are to be treated by Tendons installed to masonry wall.
- The walls towards the Pan Entrance needs to be treated with installation of a rubber tubes in the wall for the installment of the grout.
- The shops covered wall requires to have typical steel connectors for stone masonry as these walls are damaged from the inner side. This can be also supported by crack widening by removing the mortar, loose stones and gallets.

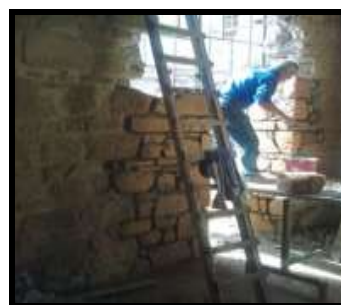
Fig. (10): Reconstruction using tie-stones.

Restoration or reconstruction of masonry walls normally involves the failure of one of the two leafs, most commonly the external. In any case it will require the reconstruction of the faulted part and strengthening of the connection using tie-stones (Fig. 10).

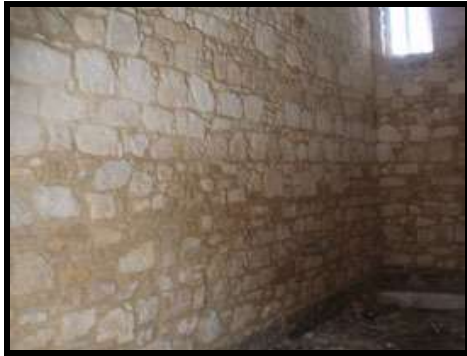
Fig. (11): Stone wall construction (elevation).

After completion of construction the wall should be brushed down and cleaned with water if necessary

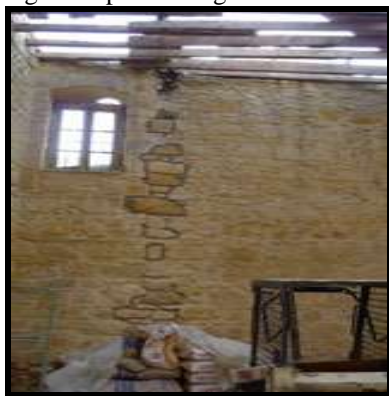
Fig. (12): Crack restoration with tie-stones.

The use of tie-stones is essential in the presence of cracks due to unconnected courses. The following procedure is essential:

- The crack is carefully widened and cleaned by brushing and washing using low abrasive tools and water
- Stones are removed along the edges of the crack every 0.50m and they are replaced with tie-stones
- Pointing is removed along the length of the crack at 0.50m on both its sides. Pointing is retained if it is very well preserved
- After the tie-stones are in place, gallets and/or pointing takes place using lime mortar

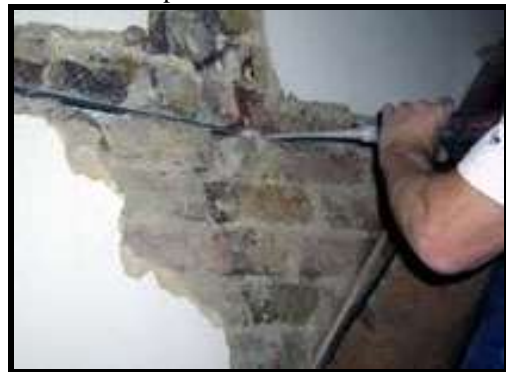
Fig. (13): Crack widening by removing the mortar, loose stones and gallets.

- The crack is carefully widened from loose stones, mortar and gallets and the opening is cleaned using low abrasive tools and water. The crack is widened at a depth of 0.15m on both sides of the wall (Fig. 13).
- Mortar and gallets are removed from both sides of the crack at 0.75m on each side at a depth of 0.15m. The opening has to be cleaned and then tie-rods (1.50m) are installed on both

sides of the wall at intervals of 1.00m in height. The tie-rods must be rustproof.

- The crack must be filled in with stones and gallets and re-pointed with lime mortar in order to complete the wall.

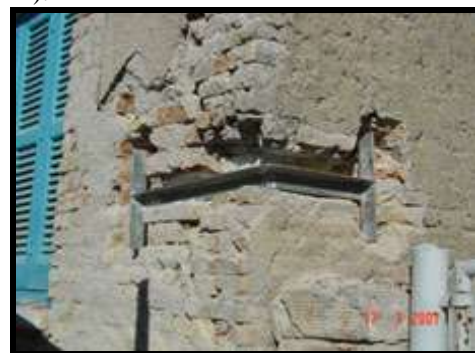
Fig. (14): Reinforcing of the corner by galvanized metal element.

When restoring a corner of a stone masonry wall then the following procedure is recommended (Fig. 14):

- Support of the roof and/or the floor
- Remove loose stones and gallets
- Reinforce the corner with rustproof plates of 1.20m minimum length in each of the two intersecting walls every 1.00m in height. Each plate must be embedded at least 0.60 m in each intersecting wall

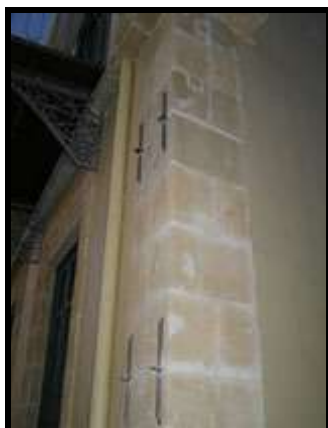
Fig. (15): Typical steel connectors for stone masonry.

Steel connectors (tie-rods) can be used to strengthen stone build structures against partial or total collapse and prevent lateral instability of the walls caused by the action of the horizontal structural members. The use of steel connectors is of great importance especially for masonry structures located in seismic zones (Fig.15).

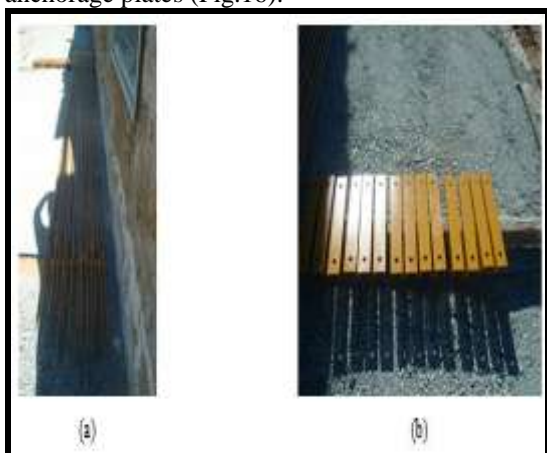
Fig. (16): Normal tendons (a) metal anchorage plates (b) corrosion resistant paint.

Although the observations of seismic damage showed significantly improved seismic behavior of the old buildings which have tied masonry walls, the practice to isolate the floors from the walls has been widely applied a few decades ago. In the normal course of rehabilitation and restoration after an earthquake or after various natural physical damages, the metal connectors are placed directly beneath the floor or at locations where it is necessary (cracking of walls at corners). For this reason, normal tendons can be used. The threaded ends are manufactured to be screwed to the ends of the wall onto a metal anchorage plates (Fig.16).

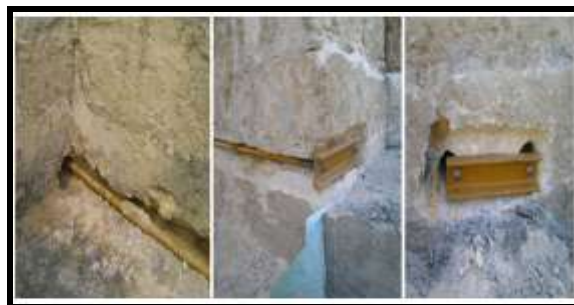
Fig. (17): Tendons installed to masonry wall.

Usually, connections are placed symmetrically on both sides of the wall in horizontal grooves of width about 4-5cm that are created on the plaster connections just below the level of the floor to the wall surface. In such case the walls do not have to be damaged (Fig.17). The rods are held in place with staples placed in holes on the wall, which are opened at the joints. The anchorage plates have thickness of at least 15mm. The length of the plates is slightly larger than the thickness of the wall, while the width is less than 200mm. A slight pretension is applied in the rods with the use of a hand tool and the nuts are screwed on the plate. All metal parts are protected

from corrosion with paint and then coated so that the connections are not visible.

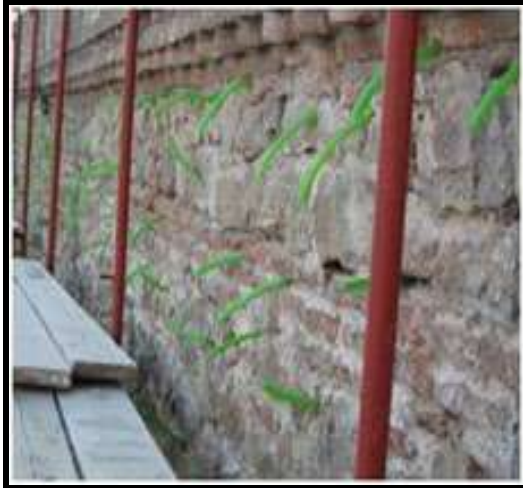
Fig. (18): Installation of a rubber tubes in the wall for the installment of the

- The holes are then cleaned from loose material and dust and the edges are smoothed. Most of the times the grout is installed using high pressure. The grout passes through the gaps filling the vacuum and squeezing or pushing the air out of the gaps of the masonry. Knowledge of the internal structure of the wall and the percentage of gaps is an element of concern for choosing the most appropriate grout mix. Grouting is performed using rubber tubes with diameters ranging from 0.3 - 0.6m (Fig.18) depending on the amount of grout

- Since the grout takes the place of air or of any water, care must be taken so that there are at least two holes next to each other. Grouting requires the involvement or supervision of experienced staff that can make decisions as to which grout mix to be used and the location of the holes. The distances between the tubes and the quantity of grout depend on the nature and viscosity of the grout, the pipe diameter, the permeability of the wall, and the intake pressure of the

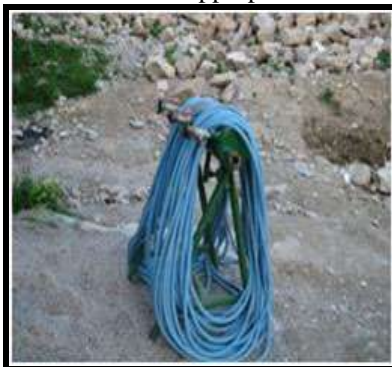
Fig. (19): Equipment for the control of the pressure.

- The initial pressure is kept constant and 30 MPa until the grout is absorbed by the wall (Fig.23). Then it is increased to 40 MPa and held steady for 5-10 minutes so that the mixture is stabilized and excess water is drained. However high pressure can create problems to low strength masonry and for this reason the pressure to be used should be calibrated. The injection of the grout starts from the lower part of the wall and continues upward in a systematic way. The lower holes are filled first until there is an overflow of grout from holes at the higher level. Then the lower tubes are sealed. The next holes to fill are those that are overflowed by the grout injection at a lower level and the process is continued until all holes are filled (Fig. 19). In the case that grout is inserted in the wall but there is no overflow from a higher level hole then there is a problem which has to be addressed. Ways to do that include the drilling of holes at closer distance or the use of grout with less viscosity. When the process is complete the tubes are removed and the holes are covered with appropriate finish.

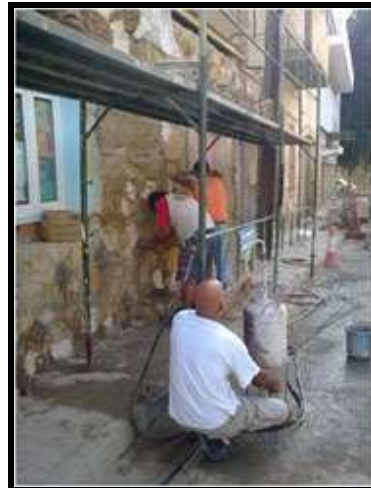
Fig. (20): An overflow of grout from holes at a higher level.
