Original Article

Basement Construction Success Prevents Cracked Heritage Buildings

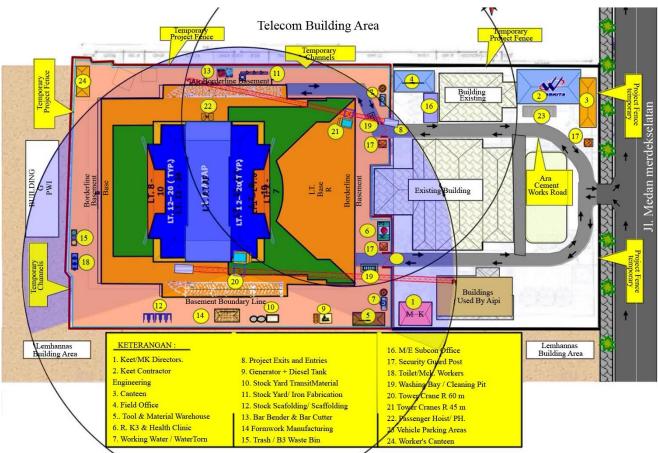
Fig. 2 The site layout was narrow, which should put all the construction needs

The site layout must be attended to during the construction stages (Figure 2).

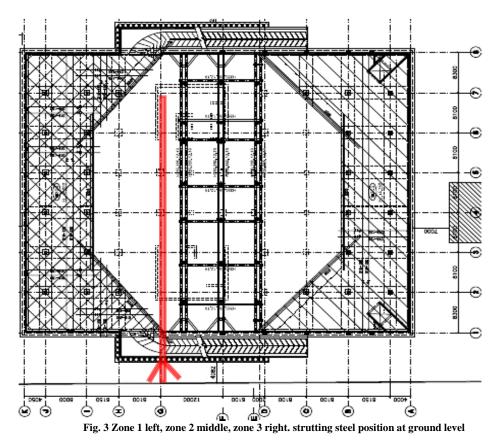
The construction method became the main in installing strutting steel because of limited space work (Figure 3).

Strutting had to be the horizontal force of active soil pressure, groundwater pressure, and pressure building load on the site next to it. The strutting steel should also be calculated for horizontal and vertical deflection (Δ) that

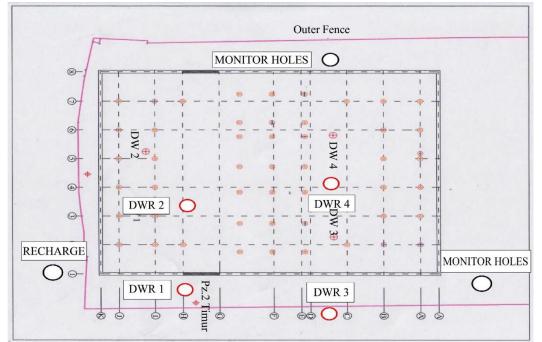
Fig. 5 Dewatering (D.W.) and Recharge (Pz) location

Recharge to outside basement construction. Dewatering done in the diaphragm wall area (Figure 5) Groundwater outside the diaphragm wall should be monitored and measured, and groundwater should not be drastically dropped to avoid the impact of damage to heritage and infrastructure buildings. The outside basement recharged always keeps the groundwater level.

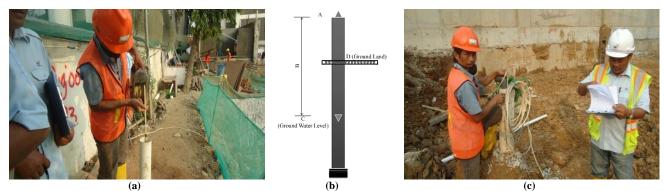
After recharging, observations of groundwater levels (Figure 6 a,b,c), and the engineer's inspection of the walls of heritage buildings, no deformation/ unchanged remains.

Fig. 6 (a) Recharge, (b) Measurement noted and (c) Groundwater control (source: author document)

Water monitoring should analyze the decline; groundwater decreased by more than 30 cm should be recharged immediately. Example (fig 6 a,b,c) Measurement of top-level A, measuring the high to B every day, the difference of high B every day indicated the decreased groundwater. Level A measurement with length B resulted in level C. The difference between level C and level D indicated the groundwater level on the soil surface.

Groundwater was monitored with a piezometer, and deformation with an inclinometer. The dewatering and recharging were observed with simple and easy construction, as shown in figures 6 a, b, and c, measuring with hose and meter until groundwater fixed the first level. This research applied 5 main groups, starting from bore piling, excavation, installing basement walls and floors, monitoring groundwater, and protecting the environment so that heritage buildings and old buildings did not crack and deform, the environment was not polluted, clean and healthy.
